***Forest and Infrastructure in Kangchenjunga Conservation Area:  
A Catalog of Images, Spring 2001-2002***

Chris Carpenter, Val Stori, Laxmi Dewan, students and staff of  
Wildlands Studies Nepal Program, 2001 (spring) and 2002 (spring)

in cooperation with  
World Wildlife Fund, Nepal.

October 19, 2002

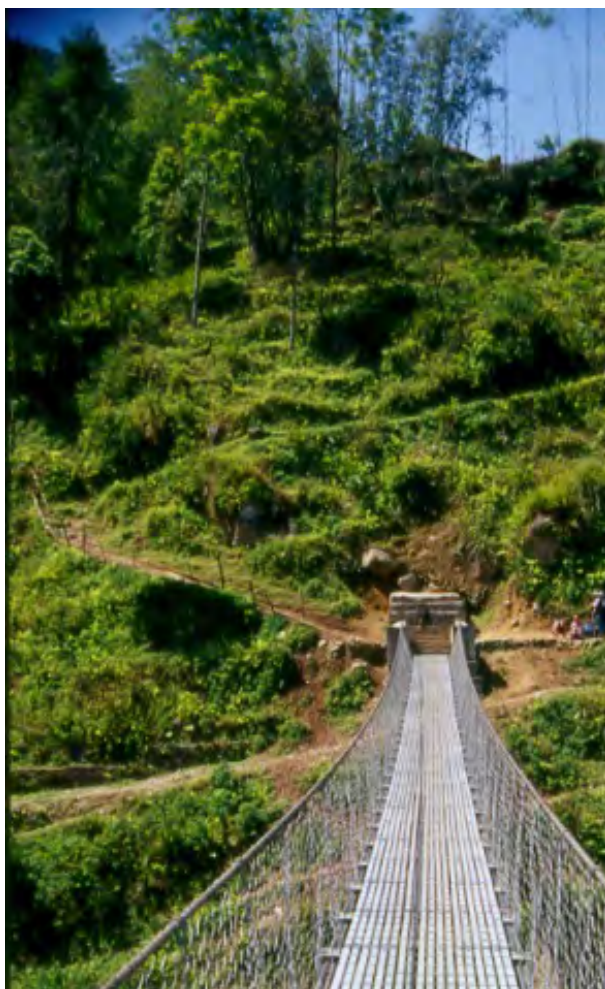
Construction Style: Suspension bridge, about 80 m long
Condition: Very good
Possible Hazards: No special particular concerns at this time
Recommended Maintenance: Not now

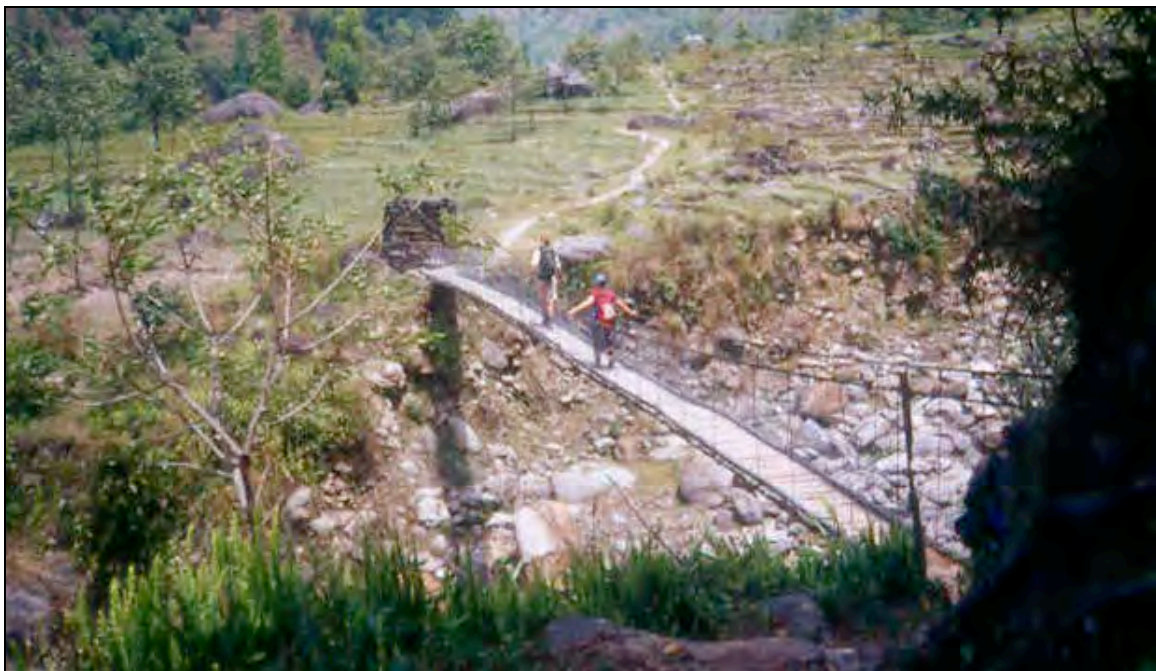
Number: 2	Stream: Tapegio (?) Khola	27 April 2002
Lat. 27 deg. 29.368' N	Long. 87 deg. 45.922' E	Elevation: 1340 m
Location: Tributary of Tamur Khola, 45 minutes up the main trail from Chiruwa		
Description: Steel suspension bridge with wooden planks, about 30 m long		
Construction Style: Suspension bridge, about 80 m long		
Condition: Needs maintenance		
Possible Hazards: Gaps where wooden planks are missing, wire fencing on side is torn with holes large enough to fall through. Torn wire fencing is sharp - easy to cut hands.		
Recommended Maintenance: Broken boards and wire fencing should be repaired or replaced.

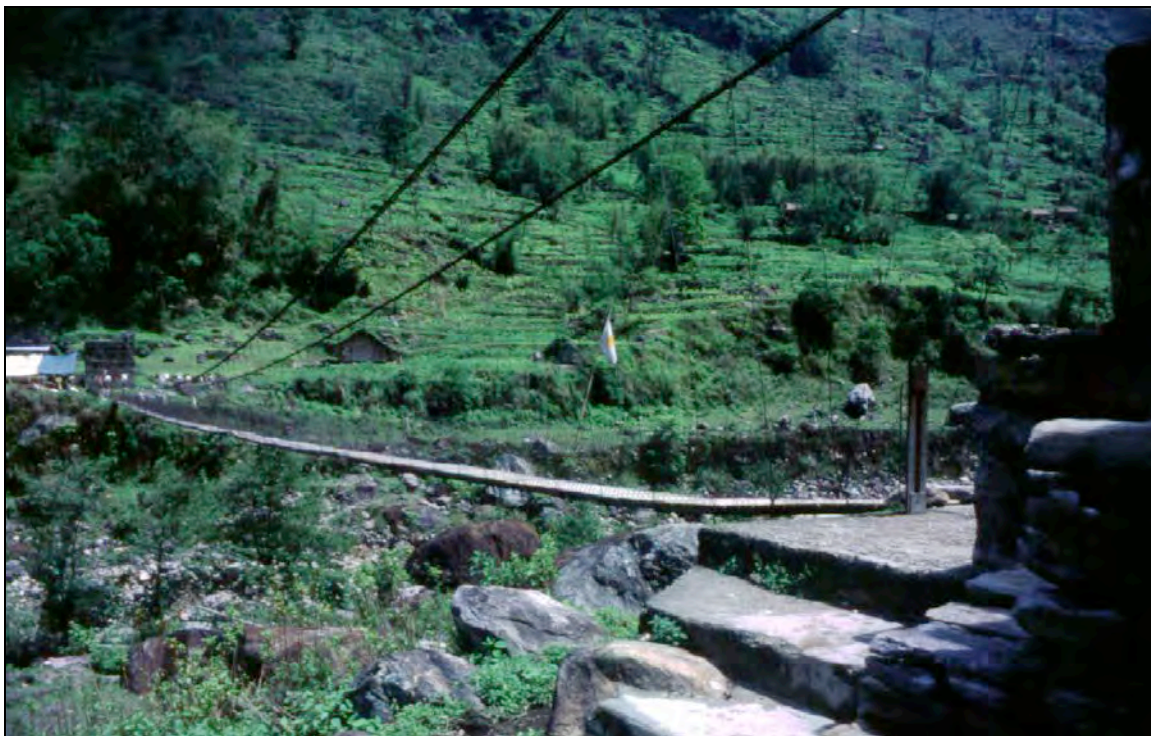
Number: 3	Stream: Tamur River	27 April 2002
Lat. 27 deg. 29.517' N	Long. 87 deg. 46.361' E	Elevation: 1340 m
Location: Thapatok Bazar		
Description: Long suspension bridge with rock tower anchoring the SE end.		
Construction Style: Suspension Bridge		
Condition: Needs some maintenance		
Possible Hazards: Gaps where planks are broken, wire fencing on side is torn along the length of the bridge. Several planks missing at the end of the bridge.		
Recommended Maintenance: Replace broken boards, repair fencing.

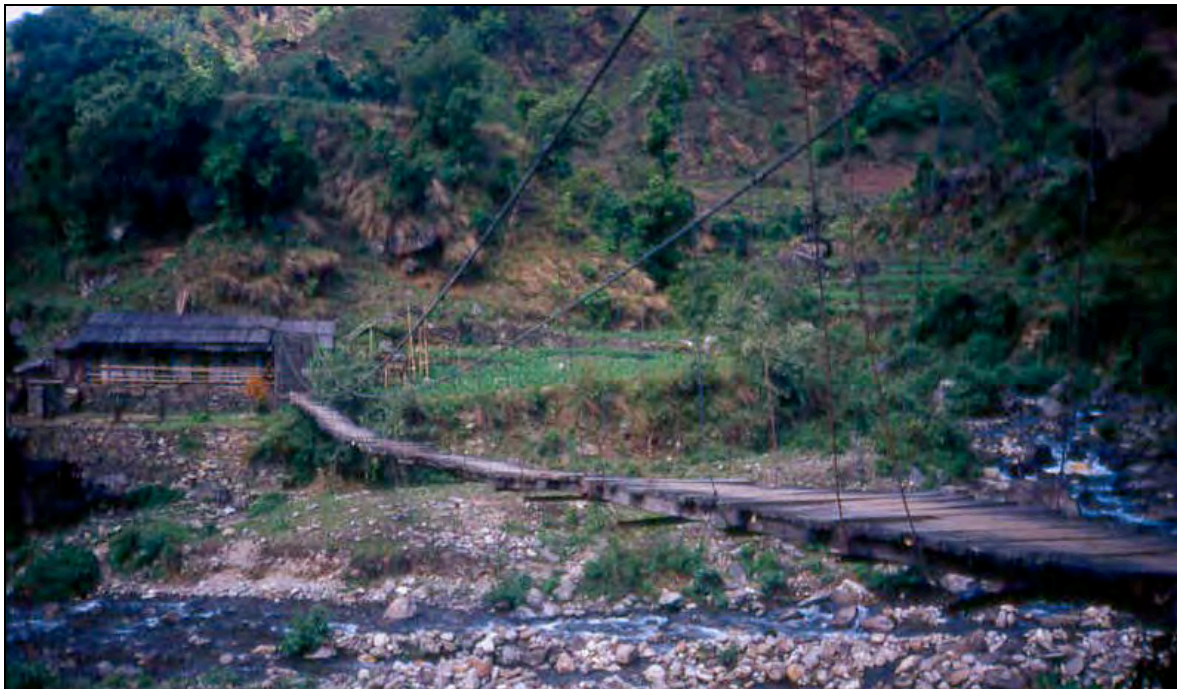
Number: 4	Stream: Sambewa Khola	27 April 2002
Lat. 27 deg. 30.593' N	Long. 87 deg. 47.822' E	Elevation: 1460 m
Location: Tributary of Tamur Khola, flows down through small settlement of <i>Chilaune</i> on main trail between Thapatok and Helok.		
Description: Suspension bridge used during monsoon season		
Construction Style: Suspension bridge, about 80 m long		
Condition: Poor. Planks are rotten, many are broken or missing. No side-fencing		
Possible Hazards: Danger of falling through rotten planks, or falling off side of bridge.		
Recommended Maintenance: Recommend to replace the planks

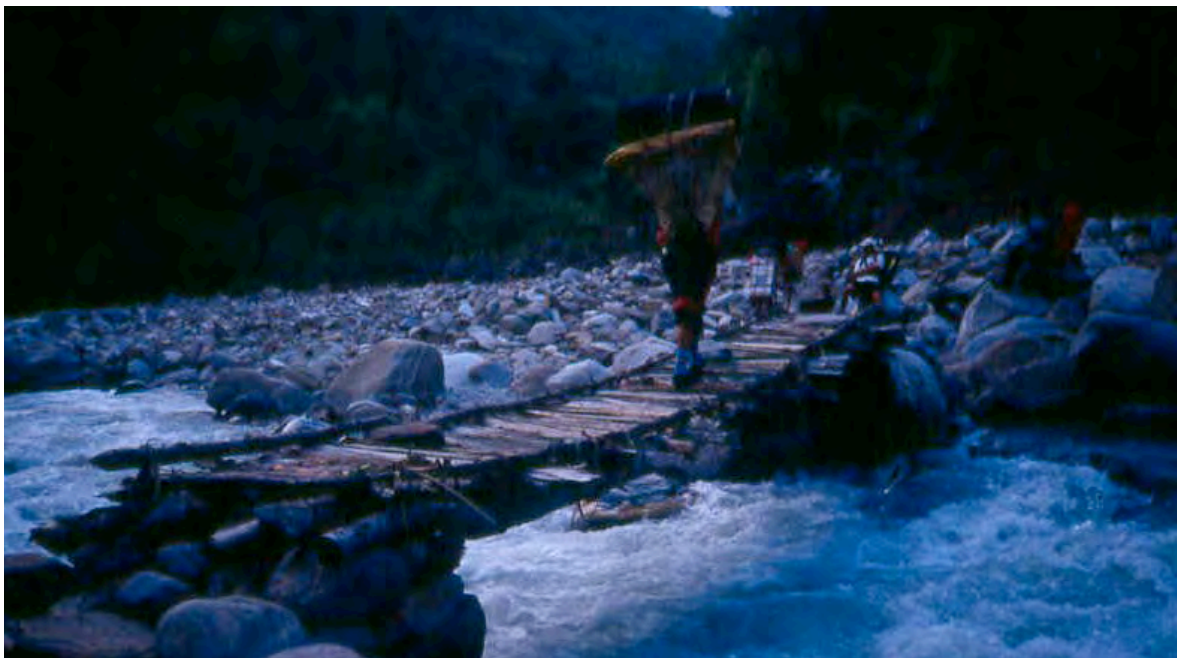
Number: 6	Stream: Simbuwa Khola (S. Fork Tamur)	27 April 2002
Lat. 27 deg. 31.561' N	Long. 87 deg. 48.246' E	Elevation: 1510 m
Location: Crosses Simbuwa Khola just above confluence with Tamur		
Description: Temporary bridge used during winter season. Needs to be rebuilt after every monsoon.		
Construction Style: Wood plank cantilever bridge		
Condition: Good, but likely to wash away in a few weeks		
Possible Hazards: Cross carefully to avoid falling in the river. Take extreme care at high water.		
Recommended Maintenance:

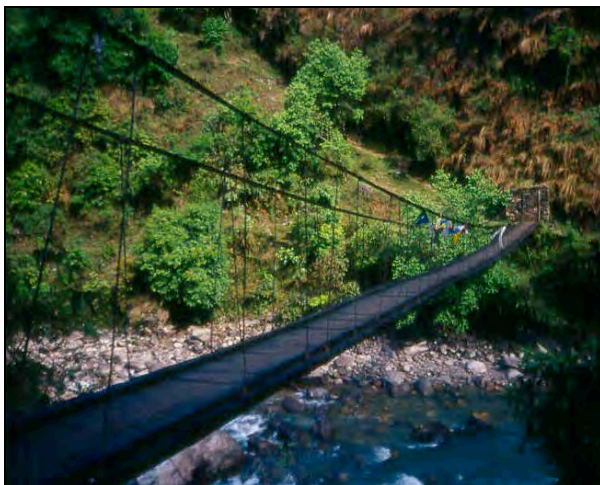
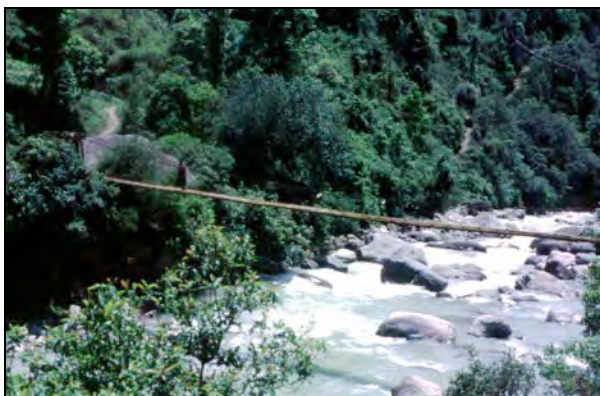
Number: 7	Stream: Ghunsa Khola	29 April 2002
Lat. 27 deg. 32.075' N	Long. 87 deg. 48.371' E	Elevation: 1560 m
Location: Sakathum		
Description: Suspension bridge held anchored by stone anchors, wooden planks, welded clasps.		
Construction Style: Suspension bridge about 50 m long		
Condition: Weathered, but reasonable condition		
Possible Hazards: Some wooden planks need replacement, cable frayed in many places.		
Recommended Maintenance: Broken boards may need to be repaired or replaced in enar future. Less urgent here than on other bridges in the area.		
Photograph: # 9

Are these two the same?

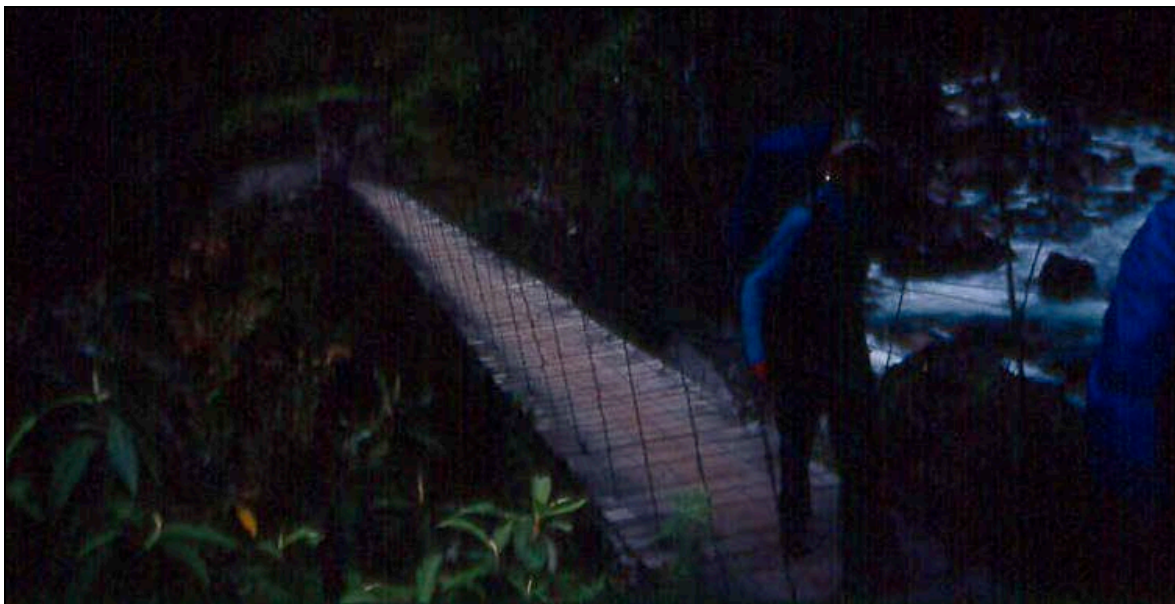
Number: 8	Stream: Ghunsa Khola	29 April 2002
Lat.	Long.	Elevation:
Location: Ghunsa Khola between Sakathum and Amjilassa, on main path. This is the first suspension bridge along the climb from Sakathum to Amjilassa.		
Description: Suspension bridge about 40 m long		
Construction Style: Steel cable attached to stone anchors on either side, wooden planks connected by metal wires.		
Condition: Bridge seems to be unstable.		
Possible Hazards: Some of the base board planks seem unsafe.		
Recommended Maintenance: May be necessary in near future.

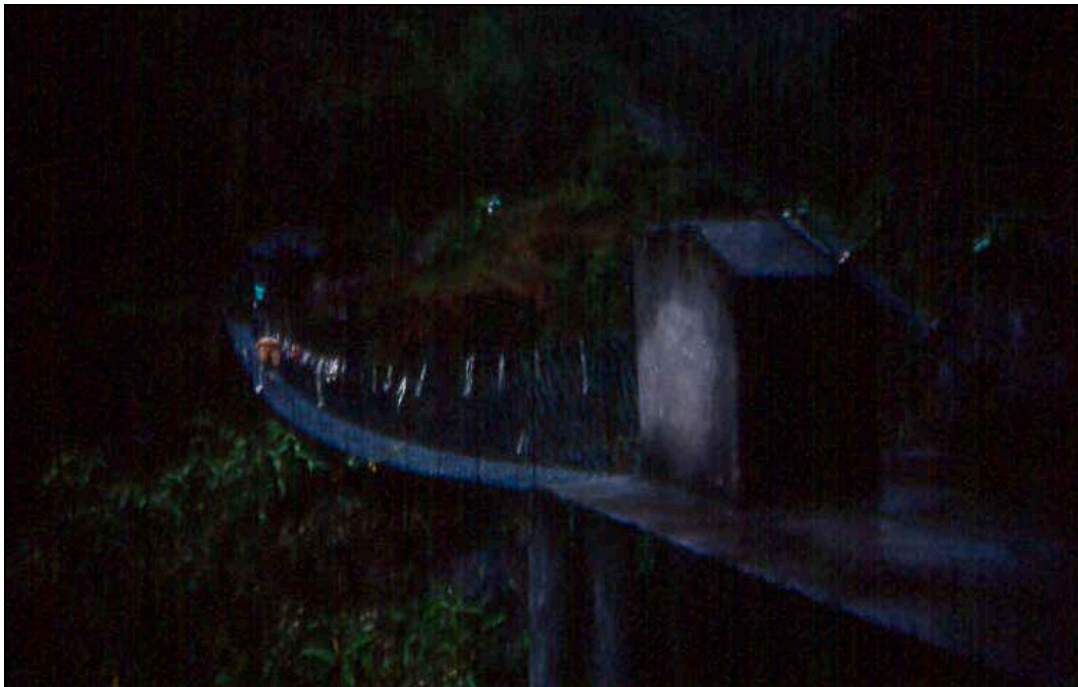
Number: 9	Stream: Ghunsa Khola	29 April 2002
Lat. 27 deg. 33.534' N	Long. 87 deg. 50.962'	Elevation: 1960 m
Location: Between Sakathum and Amjilassa, on main path.		
Description: Steel suspension bridge with concrete anchors, in good condition, recently constructed.		
Construction Style: Suspension bridge about 50 m long.		
Condition: Very good		
Possible Hazards: No hazards evident at this time.		
Recommended Maintenance: Not now		
Photograph: # 11

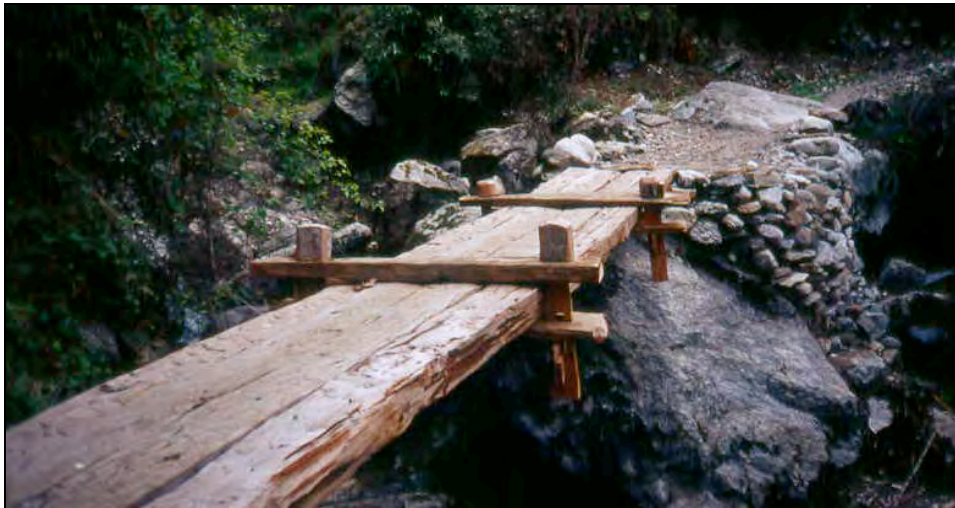
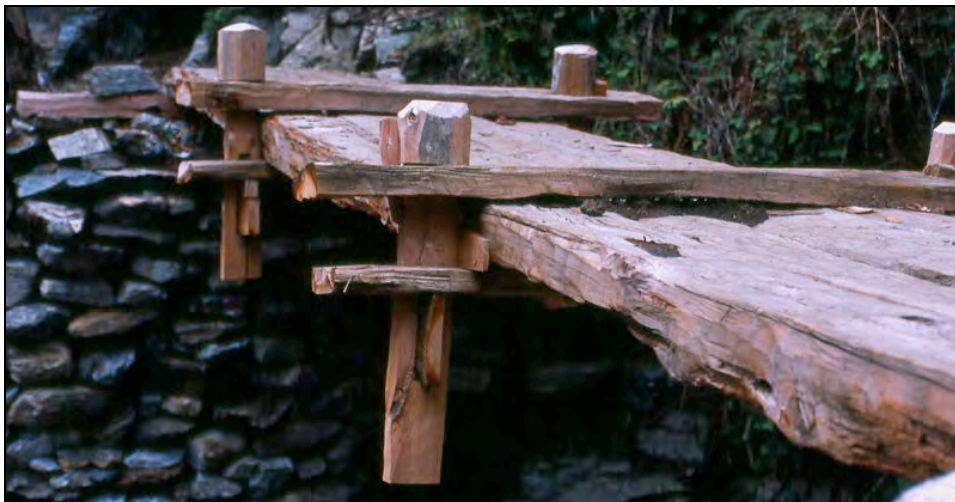
Number: 10	Stream: Tributary of Ghunsa Khola	30 April 2002
Lat. 27 deg. 36.127' N	Long. 87 deg. 52.128' E.	Elevation: 2440 m
Location: Between Amjilassa and Gyepla		
Description: Wood post and beam construction.		
Construction Style: Suspension bridge about 50 m long.		
Condition: Very good		
Possible Hazards: Bridge could wash out after a flood.		
Recommended Maintenance: Check periodically for cracking or decay

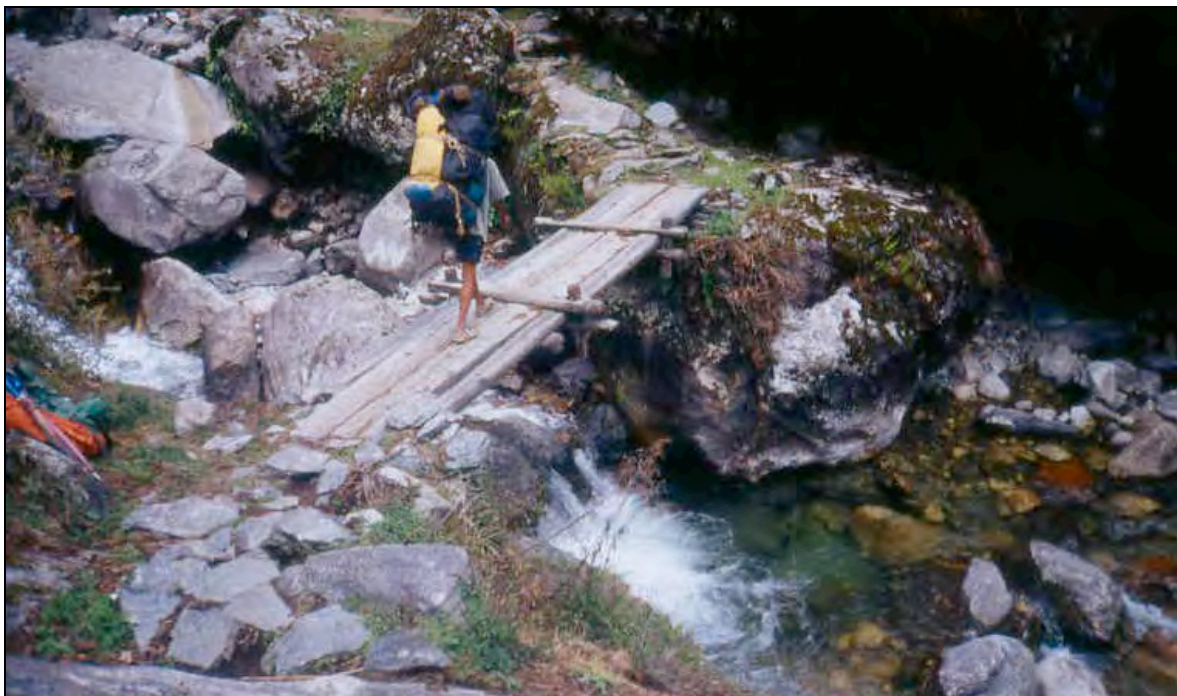
Number: 11	Stream: Gyepla Khola South	30 April 2002
Lat. 27 deg. 36.480' N	Long. 87 deg. 52.243'	Elevation: 2510 m
Location: 30 minutes below Gyepla on main path.		
Description: Wooden footbridge between large boulders - waterfalls above and below.		
Construction Style: Wooden post and beam		
Condition: Weathered, but good condition		
Possible Hazards: Some risk of washout during monsoon.		
Recommended Maintenance: Check periodically for cracking or decay

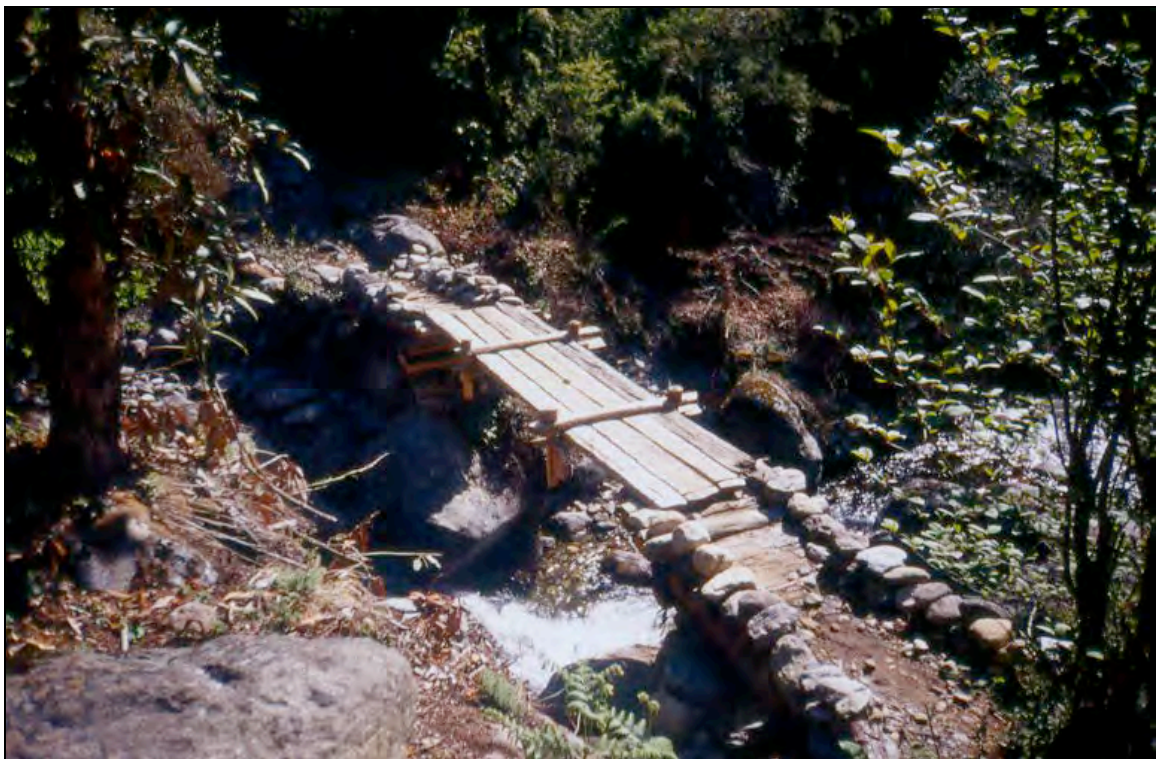
Number: 12	Stream: Gyepla Khola North	1 May 2002
Lat. 27 deg 36.958' N	Long. 87 deg 52.770' E	Elevation: 2740 m
Location: 15 minutes beyond Gyepla on main path to Phole.		
Description: Wood plank footbridge with cantilevered ends.		
Construction Style: Wooden post and beam with rock supports		
Condition: New, very good condition		
Possible Hazards: Some risk of washout during monsoon flooding.		
Recommended Maintenance: Not now

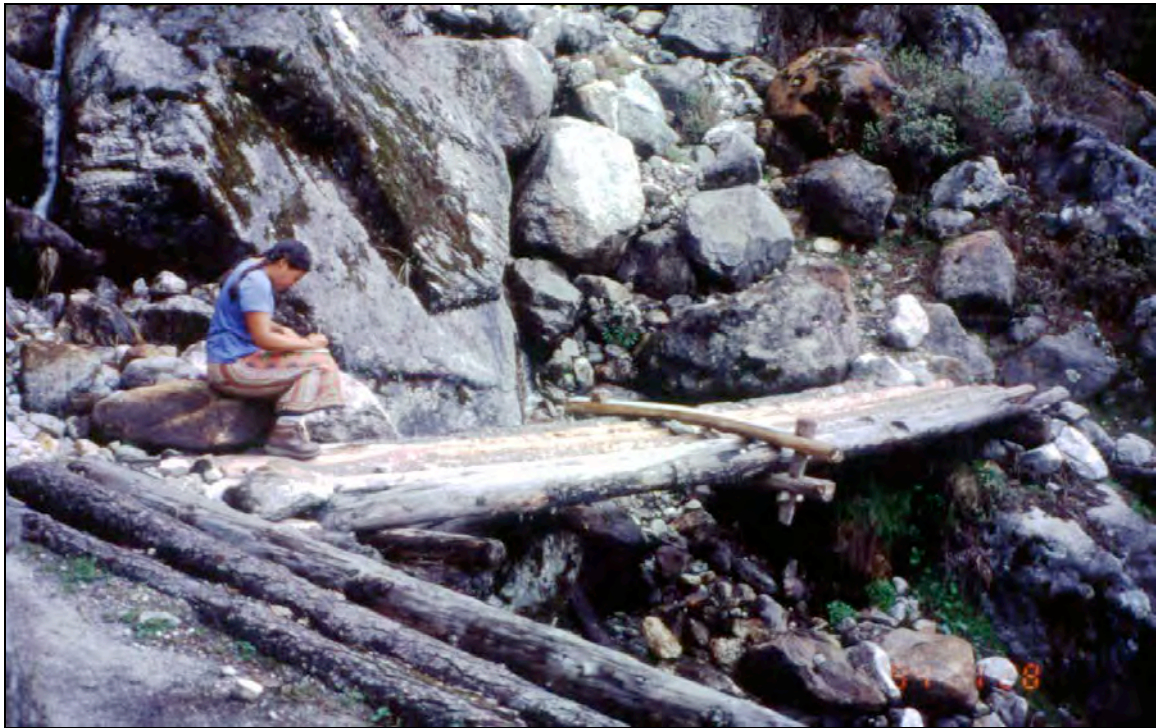
Number: 13	Name of Stream:	18 May 2001
Lat. 27 deg. 39.166' N	Long. 87 deg. 55.085' E	Elevation: 3350 m
Location	Main path between Phole and Ghunsa	
Description	Simple wooden bridge across a steep gully. 7 small, uncut logs clamped in the middle with a wooden cross brace. Held with rocks at either end.	
Construction Style	Simple trestle	
Condition	Adequate for the site.	
Possible Hazards	Some risk of washout during monsoon flooding.	
Recommended Maintenance	Probably needs to be maintained or replaced at the end of the monsoon season.

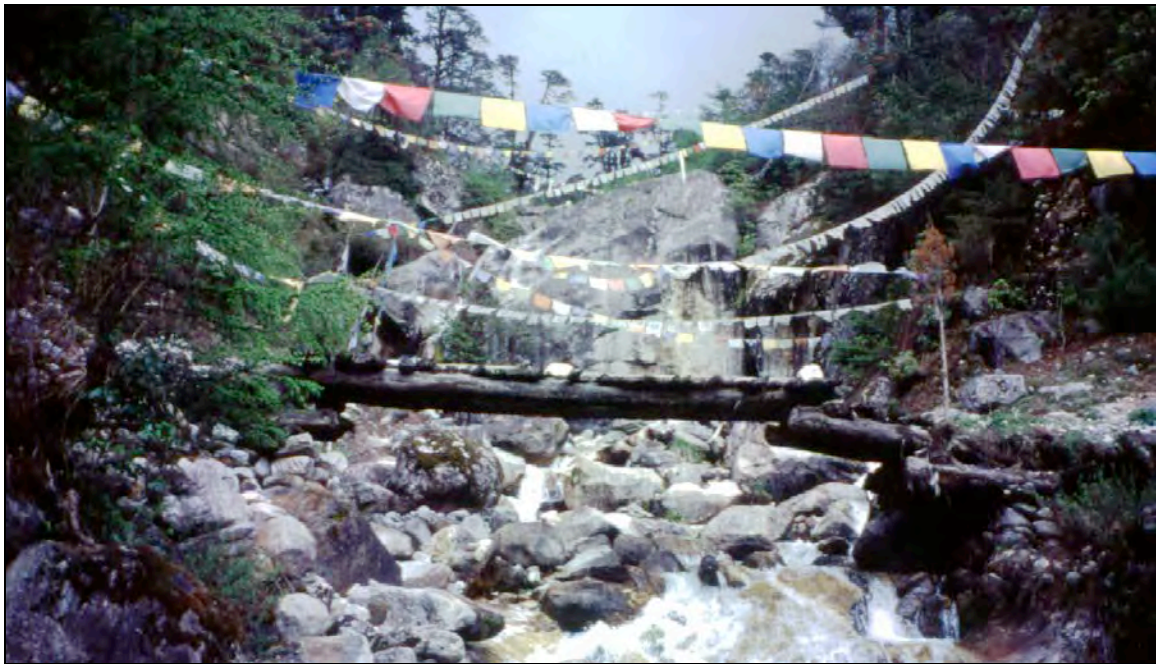
Number: 14	Name of Stream: [Kang La] Khola	18 May 2001
Lat. 27 deg. 39.166' N	Long. 87 deg. 55.085' E	Elevation: 3350 m
Location	Kang La Phedi, 10-15 min. above Phole on main path from Phole to Ghunsa. Biggest bridge between Ghunsa and Phole	
Description	Seven logs suspended at the ends by rock-weighted braces, cross planks, no rails.	
Construction Style	Cantilever style	
Condition	Adequate for the purpose - this bridge receives heavy local traffic between Phole and Ghunsa	
Possible Hazards	None	
Recommended Maintenance	Not now, check structure periodically.

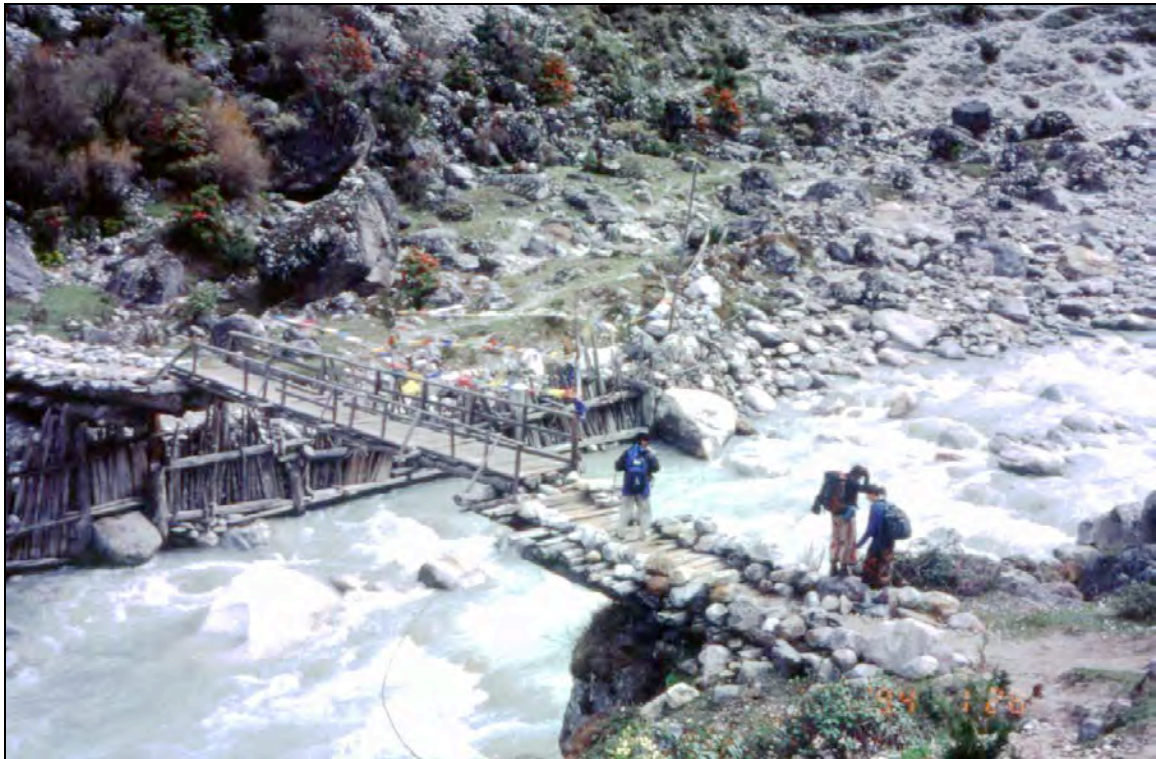
Number: 15	Name of Stream: Ghunsa Khola	12 May 2001
Lat.	Long.	Elevation: 3420 m
Location	Ghunsa Village	
Description	Wooden cantilever bridge, approximately 25 m long. Logs, wooden planks, river stones. Logs span stream between cantilevered braces, planking on top. Also includes hand rails and a retaining wall to stabilize stream bank. Also	
Construction Style	Cantilever-style bridge.	
Condition	Seems adequate as a footbridge	
Possible Hazards	Rocks that secure cables could shift and destabilize bridge.	
Recommended Maintenance

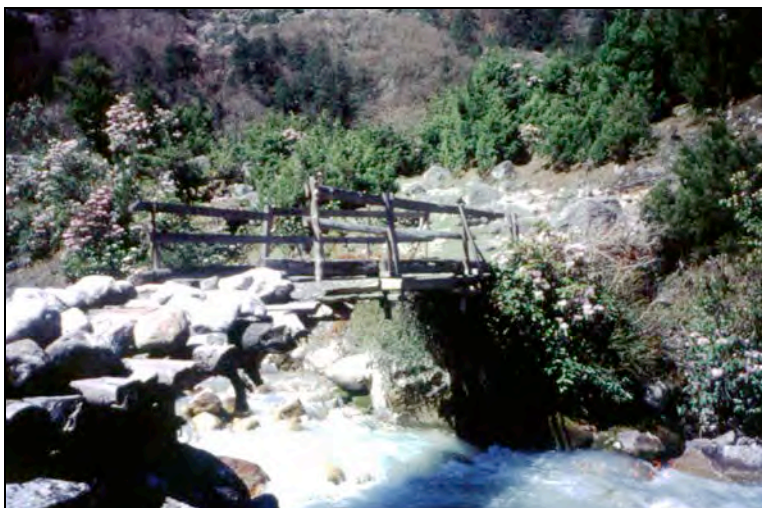
Number: 16	Stream: Yamtori Khola	12 May 2001
Lat. 27 deg. 39.191' N	Long. 87 deg. 55.915' E	Elevation: 3526 m
Location	Adjacent to Yamtori Kharka, ~ 20 minutes from Ghunsa.	
Description	Wooden bridge, about 6 m long with approach ramp on one side. Bridge is made of 6 long boards, held by cantilevered braces with four support beams, two in the middle and two on the sides. Ramp is made of logs supported by beams against with rocks placed at sides.	
Construction Style	Cantilevered wooden bridge with rails.	
Condition	Bridge is likely high enough to withstand monsoon and snowmelt runoff, base is sturdy, but railing is loose.	
Possible Hazards	Railings could collapse.	
Recommended Maintenance	Railing should be reinforced.

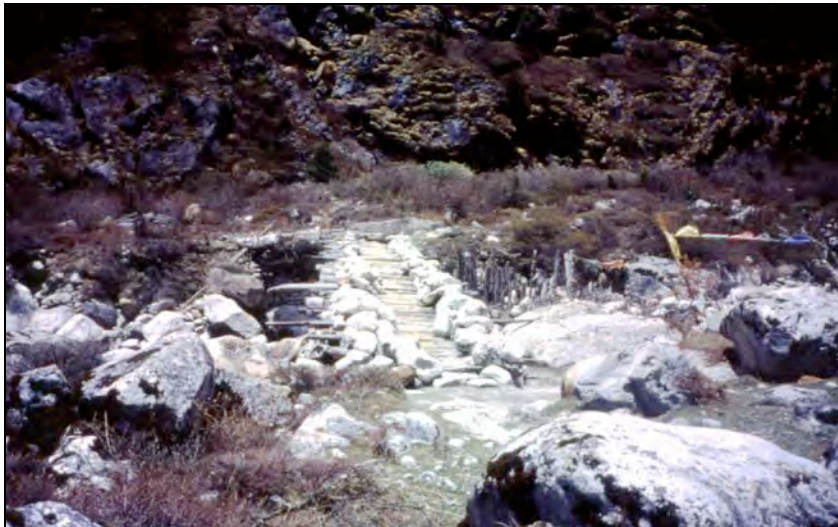
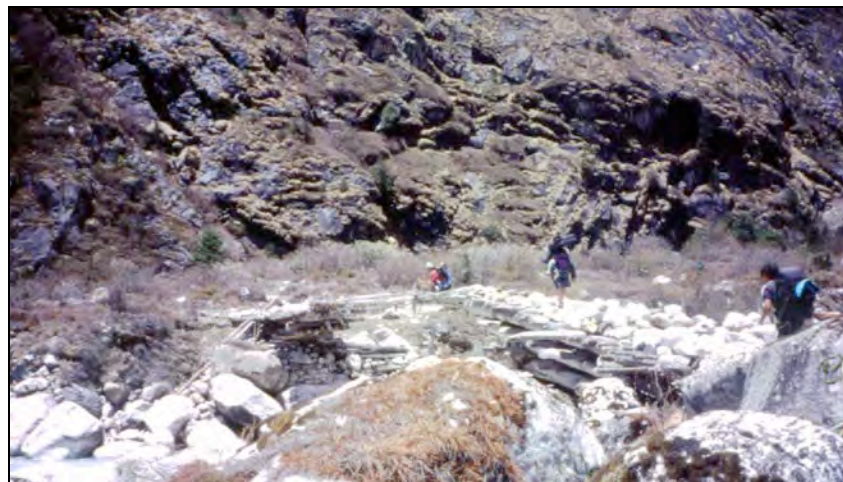
Number: 17	Name of Stream: Ghunsa Khola	13 May 2001
Lat. 27 deg. 42.474' N	Long. 87 deg. 57.928	Elevation: 3630 m
Location	Lakep Karka.	
Description	Wooden bridge, approximately 75 ft long and 5 ft wide with cantilever braces at each end. Logs with planks across the top, and tree branches wedged between boards. Cantilevers built with logs, held in place by tongue and groove base.	
Construction Style	Wooden cantilever bridge. No handrails.	
Condition	Cantilever braces are sturdy, bridge is old and unstable.	
Possible Hazards	Gaps between planking. The middle 3 m section of the bridge is unstable.	
Recommended Maintenance	Gaps should be filled. Bridge should be reinforced or replaced.

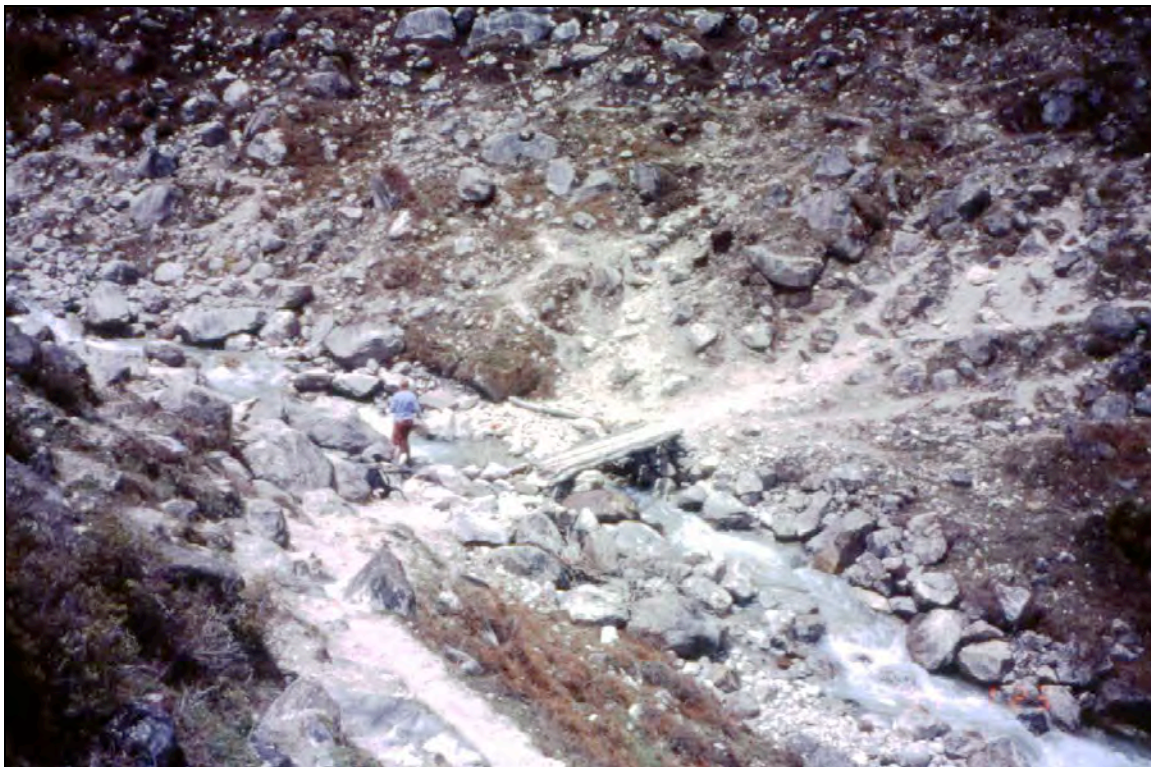
Number: 18	Name of Stream: Laphuk Khola	13 May 2001
Lat. 27 deg. 43.371' N	Long. 87 deg. 57.773' E	Elevation: 3780 m
Location	Laphuk Kharka, below a scenic waterfall en route to Kembachen. Immediately down valley from the big landslide.	
Description	Log bridge about 3 m long across a small stream. Composed of 5 split logs braced with rocks.	
Construction Style	Temporary log bridge.	
Condition	Bridge is short and sturdy.	
Possible Hazards	None observed.	
Recommended Maintenance	None recommended.

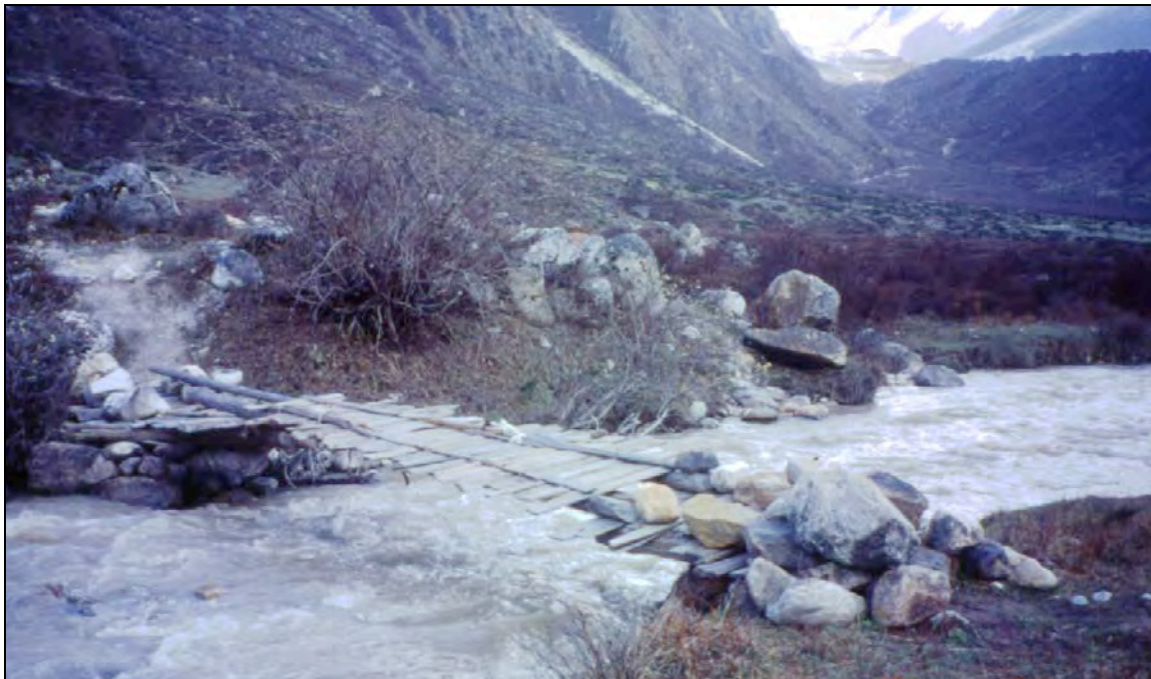
Number: 19	Name of Stream: Kembachen Khola	14 May 2001
Lat. 27 deg. 44.166' N	Long. 87 deg. 58.340' E	Elevation: 4100 m
Location	Kembachen, near the lower entrance to the valley just southwest of Yak Hotel.	
Description	Crudely built cantilever-style wooden plank bridge anchored with stones. No railings.	
Construction Style	Cantilever with beams and planks, about 6 m long.	
Condition	Condition is adequate, bridge is stable.	
Possible Hazards	Sizeable gap in the planks at one end of the bridge, flimsy construction, otherwise intact. Not a major concern as the stream is small and local people are capable of maintaining this bridge.	
Recommended Maintenance	Not urgent. Replace missing slats, check to seasonally to insure the bridge is strong enough.

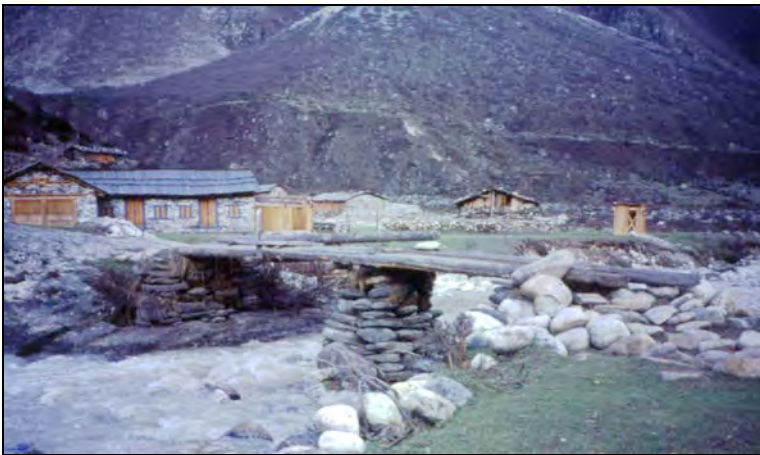
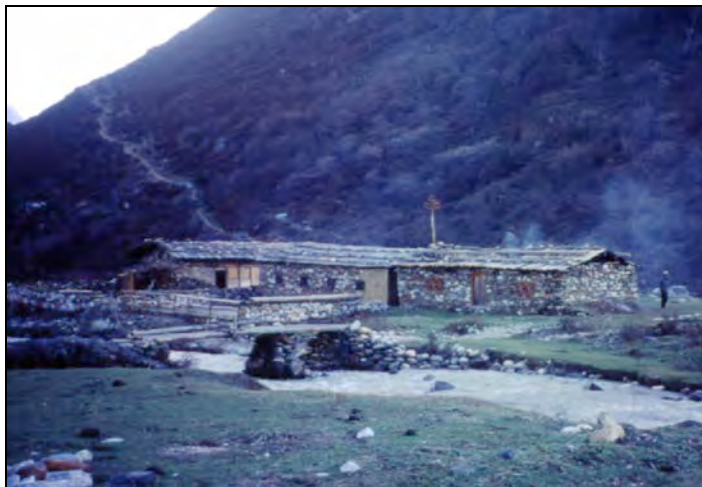
Number: 20	Name of Stream: Kembachen Khola East	14 May 2001
Lat. 27 deg. 46.224' N	Long. 87 deg. 58.314' E	Elevation: 4125 m
Location	Crosses river near the center of Kembachen's large meadow, near many recently constructed lodges and teashops.	
Description	Rock walls built along river bank provide support, prevent erosion. Rock cairn in river supports bridge at center. One clamp to hold planks together.	
Construction Style	Roughly hewn planks extend length of 6 m bridge. Structure supported by a wooden plank and stones.	
Condition	Good	
Possible Hazards	No side rails, some of planks are loose.	
Recommended Maintenance	Secure the planks

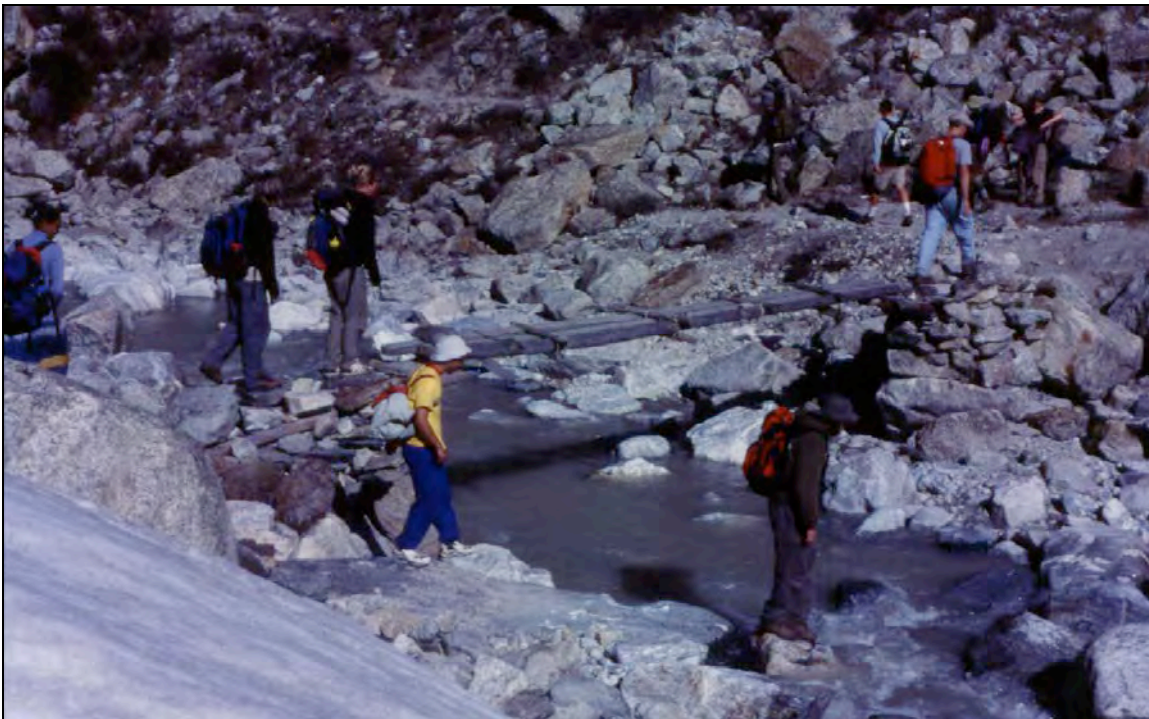
Number: 21	Name of Stream: Lhonak Khola	May 17, 2001
Lat. 27 deg. ' N	Long. 87 deg. ' E	Elevation: 4730 m
Location	SW (lower) end of Lhonak outwash plain where trail emerges onto the flats.	
Description	Plank bridge crosses a glacial stream at the lower end of Lhonak Valley.	
Construction Style	Wooden planks braced with stones. Cross-braces keep the planks in line	
Condition	Adequate for the location	
Possible Hazards	Slope at one side of the bridge hold persistent snow, makes crossing hazardous at times. During low water it is not necessary to use this bridge	
Recommended Maintenance

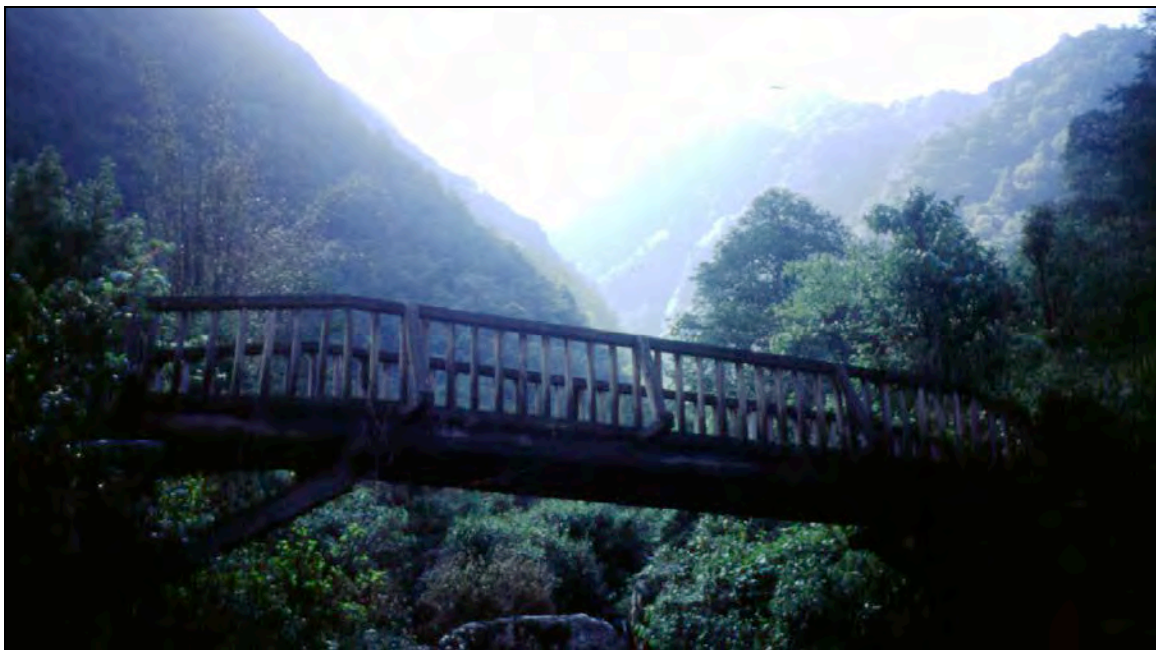
Number: 22	Stream: Otham Khola	27 April 2001
Lat. 27 deg. 24.497' N	Long. 87 deg. 53.293' E	Elevation: 1860 m
Location	Located 30 minutes north of ek chana bhanjyang.	
Description	Wooden bridge, approximately 25 ft long and 3 ft wide. Constructed of large solid pieces of wood. Necessary only during monsoon season.	
Construction Style	Wooden rail bridge.	
Condition	Condition is good, as bridge is stable.	
Possible Hazards	None observed.	
Recommended Maintenance	Not urgent.

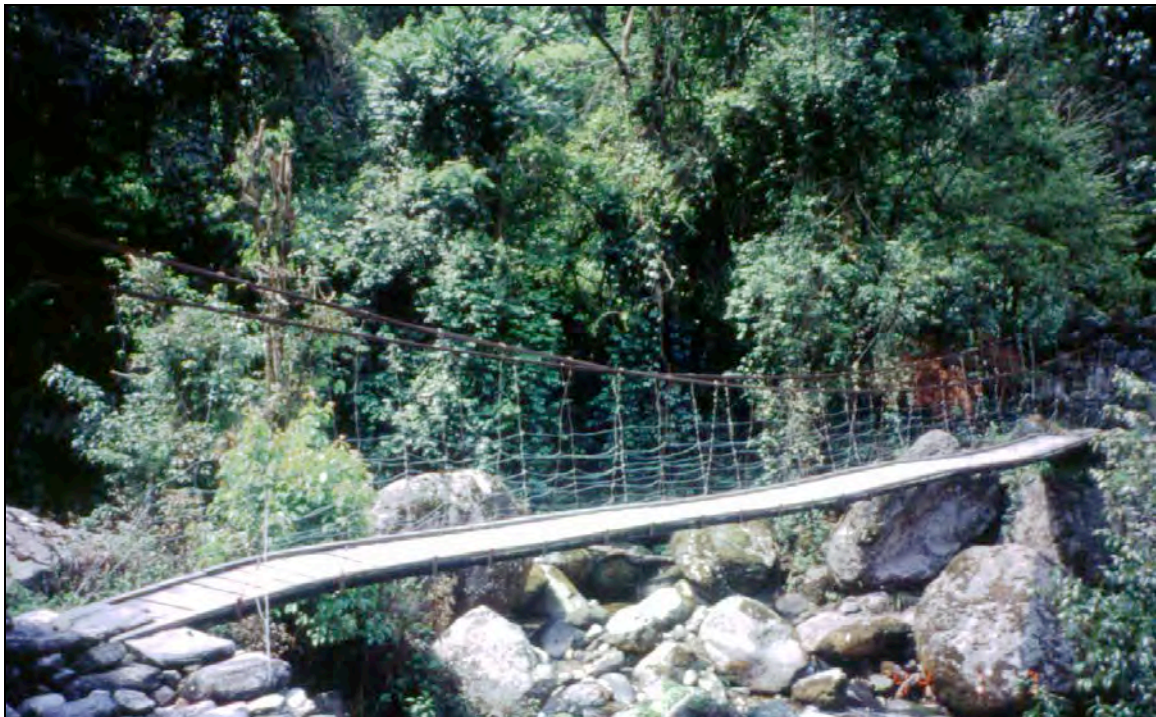
Number: 23	Stream: Rate Khola	27 April 2001
Lat. 27 deg. 26.029' N	Long. 87 deg. 53.956' E	Elevation: 1680 m
Location	Located 40 minutes away from Yamphudin.	
Description	Suspension bridge, approximately 100 ft long and 2 ft wide, connected to two large boulders. Constructed with wood, wire, cable, and rocks.	
Construction Style	Suspension bridge.	
Condition	Not missing any slats, but could use metal slats as opposed to wooden slats for stability.	
Possible Hazards	Rocks that secure cables could shift and destabilize bridge.	
Recommended Maintenance	Recommend replacement in a few seasons.

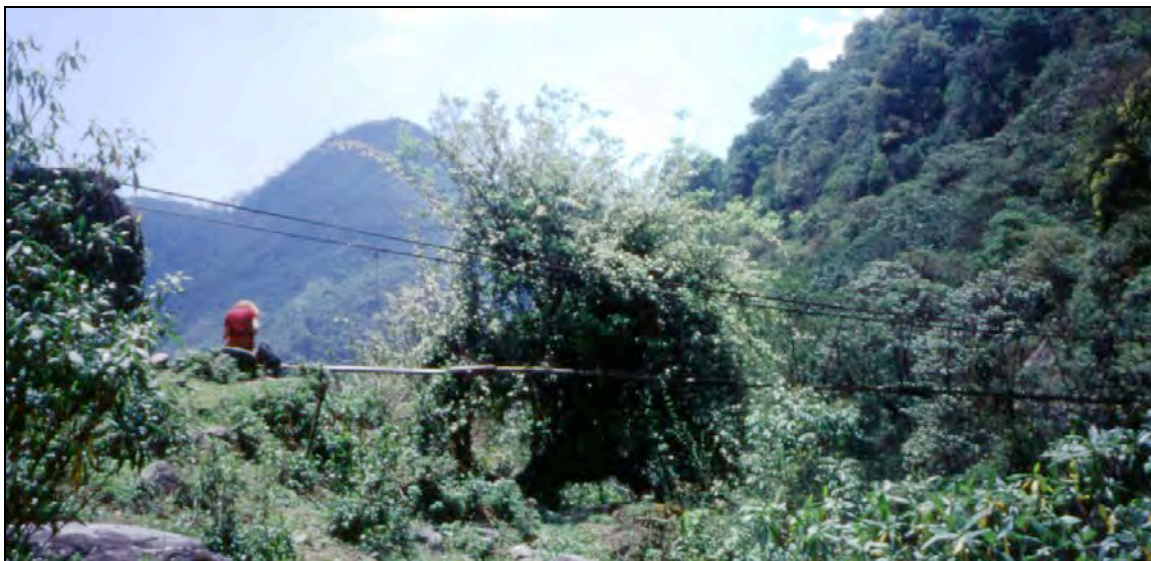
Number: 24	Stream: Kabeli Khola	28 April 2001
Lat. 27 deg. 26.502' N	Long. 87 deg. 54.126' E	Elevation: 1710 m
Location	Located 20 minutes south of Yamphudin	
Description	Single plank wooden bridge, approximately 175 ft long and 1 ft wide, held in position by two cables.	
Construction Style	Wooden suspension bridge.	
Condition	Useable, but appears quite worn and old.	
Possible Hazards	There is rotting wood present as well as broken planks.	
Recommended Maintenance	Recommend replacement in three years or less.

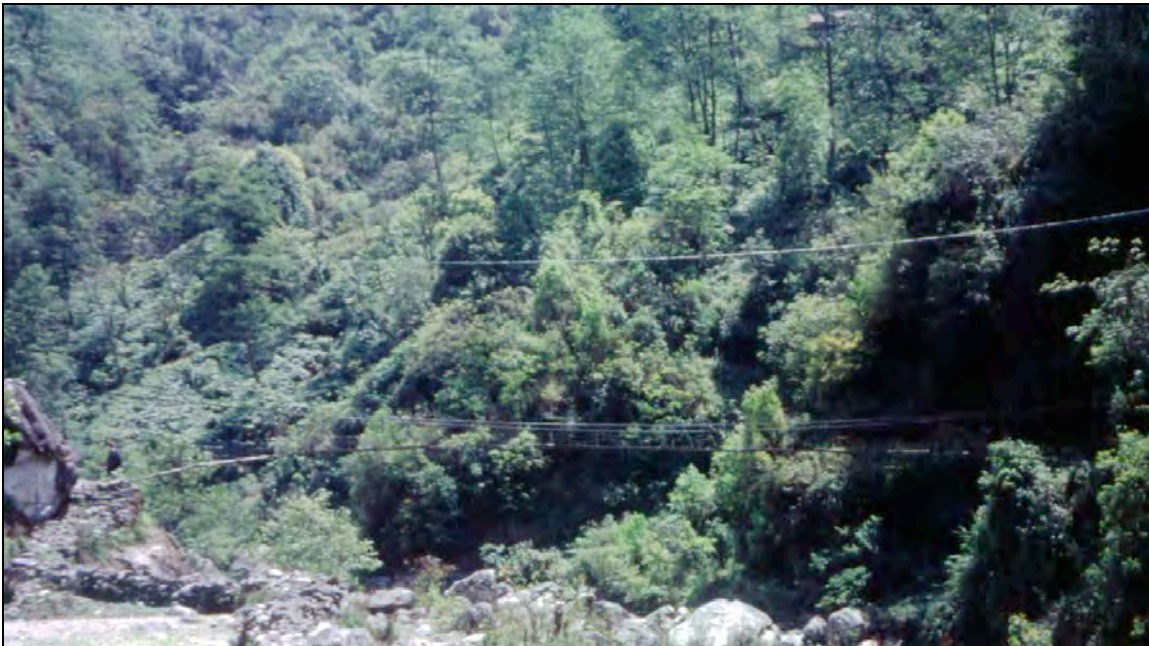
Number: 25	Stream: Kabeli Khola	27 April 2001
Lat. 27 deg. 27.233' N      Long. 87 deg. 54.820' E      Elevation: 1800 m		
Location	Located 5 minutes north of Yamphudin.	
Description	Wooden suspension bridge, approximately 200 ft long and 1.5 ft wide.	
Construction Style	Wooden suspension bridge.	
Condition	Appears old and dangerous. Bridge is unstable and there is a great deal of motion upon crossing.	
Possible Hazards	Rotting and cracked wood planks and old cables contribute to possible hazards.	
Recommended Maintenance	Recommend replacing entire bridge within two seasons.
