***Forest and Infrastructure in Kangchenjunga Conservation Area:  
A Catalog of Images, Spring 2001-2002***

Chris Carpenter, Val Stori, Laxmi Dewan, students and staff of  
Wildlands Studies Nepal Program, 2001 (spring) and 2002 (spring)

in cooperation with  
World Wildlife Fund, Nepal.

October 19, 2002

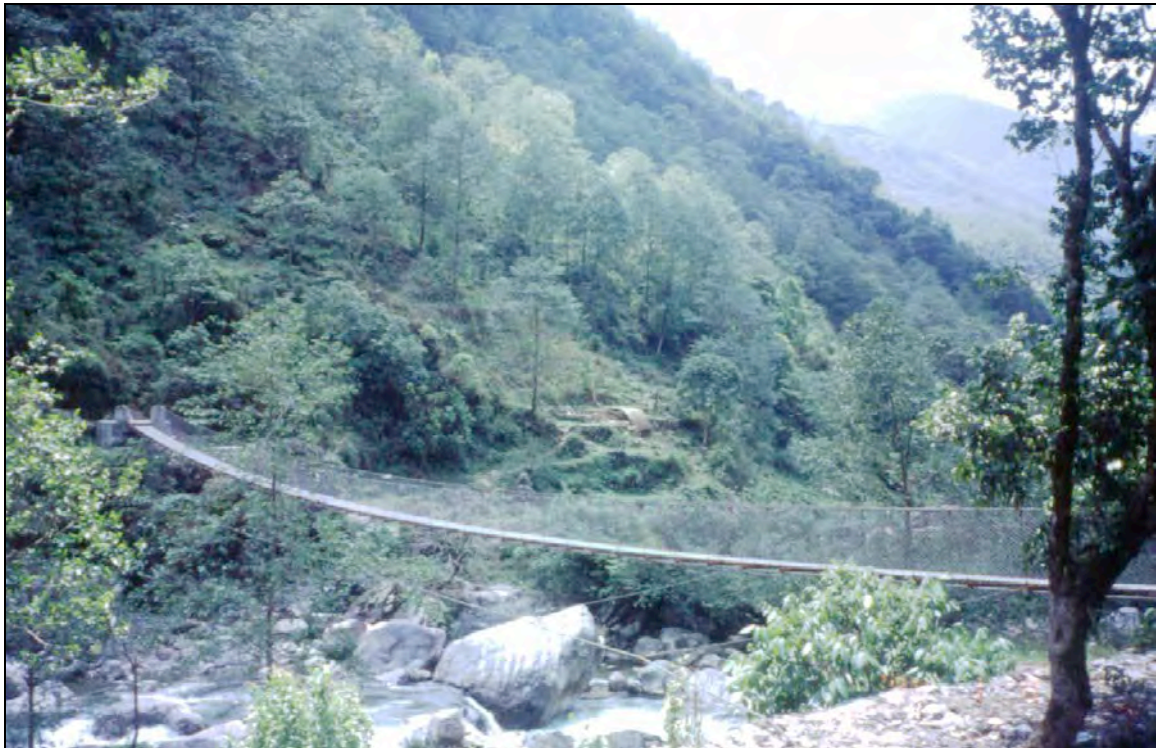
Number: 26	Stream: Kabeli Khola	28 April 2001
Lat. 27 deg. 27.231' N	Long. 87 deg. 54.823' E	Elevation: 1790 m
Location	Located in Yamphudin.	
Description	Metal suspension bridge, approximately 300 ft long and 3.5 ft wide, with chain link siding. Cables are secured by concrete blocks.	
Construction Style	Metal suspension bridge.	
Condition	Bridge is very stable and in excellent condition.	
Possible Hazards	None observed.	
Recommended Maintenance	None recommended.

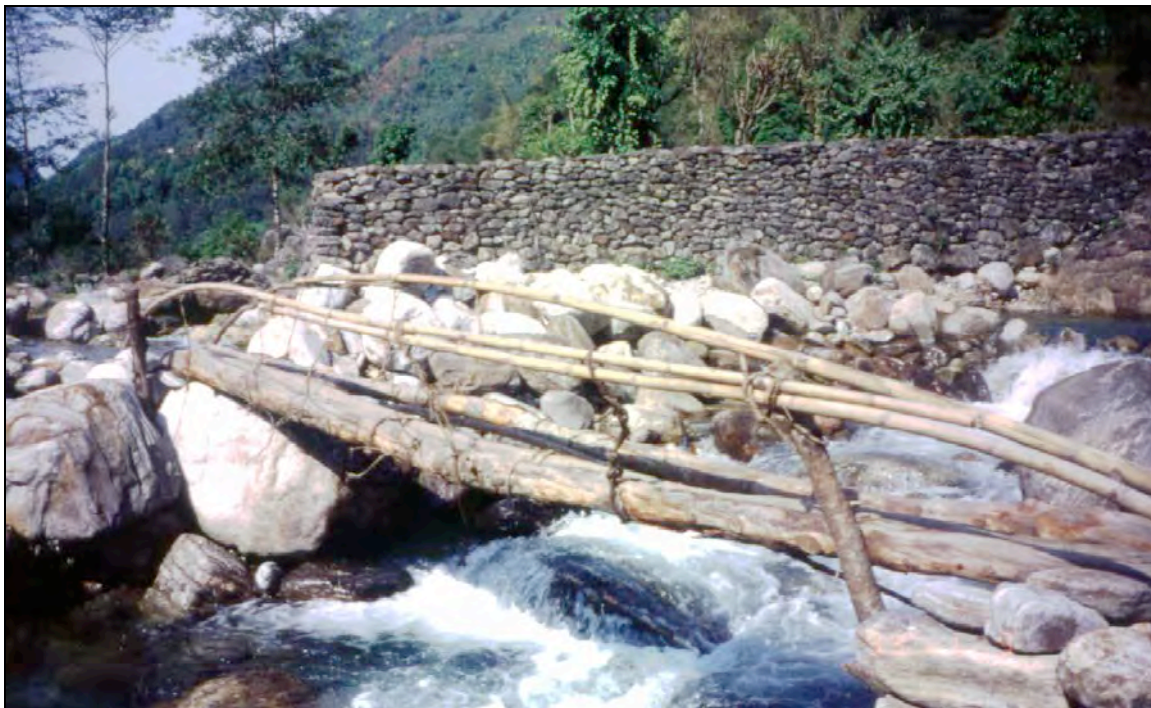
Number: 27	Stream: Lower Amje Khola	29 April 2001
Lat. 27 deg. 26.517' N	Long. 87 deg. 54.137' E	Elevation: 1720 m
Location	Located in Yamphudin.	
Description	Small bridge built with log planks and using bamboo for side rails. Secured by vines.	
Construction Style	Wooden arch.	
Condition	Fair.	
Possible Hazards	Some vines have snapped and this contributes to destabilization when crossing. There are also gaps between log planks making footing less sure.	
Recommended Maintenance	Recommend repairing railing as soon as possible and replacement in one to two years.

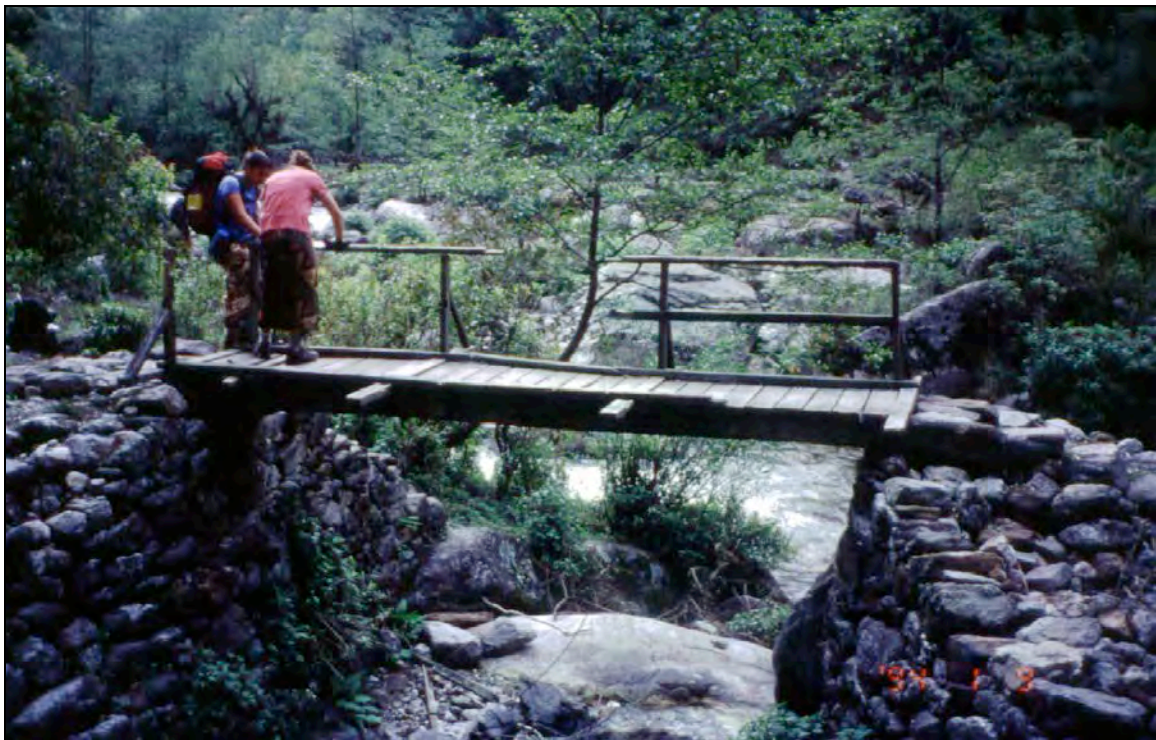
Number: 28	Stream:	29 April 2001
Lat. 27 deg. 27.475' N	Long. 87 deg. 54.793' E	Elevation: 1720 m
Location	Located 15 minutes north of Yamphudin.	
Description	Small wooden bridge, approximately 17 ft long and 3 ft wide, with tow planks running lengthwise and 2x4's running across. Wooden railing is present on south side.	
Construction Style	Wooden tressel bridge.	
Condition	Condition is fair, but railing on north side has fallen off.	
Possible Hazards	Side without railing presents potential hazard.	
Recommended Maintenance	Recommend repairing railing on north side.

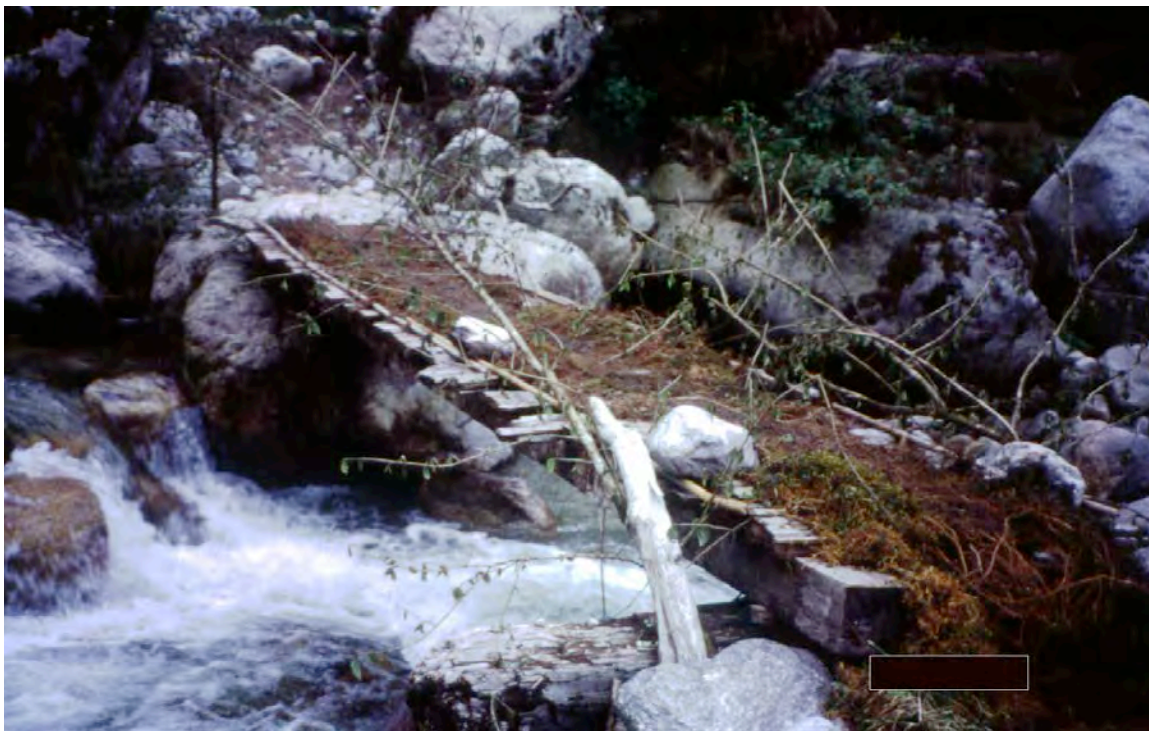
Number: 29	Stream: Omje Khola	29 April 2001
Lat. 27 deg. 27.470' N	Long. 87 deg. 54.798' E	Elevation: 1770 m
Location	Located at Omje Khola campsite.	
Description	Wooden bridge, approximately 25 ft long and 3 ft wide, made with two beams running lengthwise and 2x4's running across them.	
Construction Style	Basic foot bridge	
Condition	Moss was observed growing in between the 2x4's, but bridge is stable and in good condition.	
Possible Hazards	None observed.	
Recommended Maintenance	None recommended.

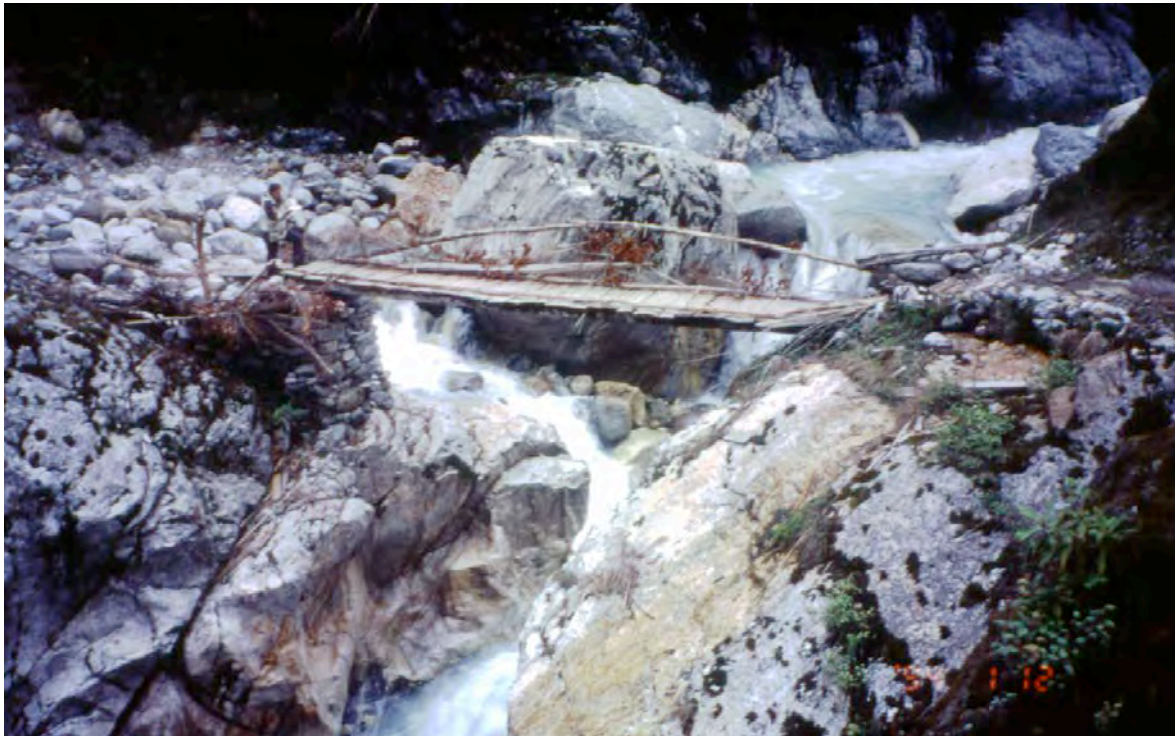
Number: 30	Stream: Simbuwa Khola	2 May 2001
Lat. 27 deg. 31.680' N	Long. 87 deg. 54.848' E	Elevation: 2930 m
Location	Torongdon.	
Description	Wooden bridge, approximately 30 ft long and 3 ft wide, made with logs running lengthwise, wooden planks running across these, and a railing of branches on north side.	
Construction Style	Wooden foot bridge, braced at ends.	
Condition	Condition is good, but railing on the south side should be replaced, and some planks are loose.	
Possible Hazards	Lack of railing on the south side could make a fall more likely.	
Recommended Maintenance	Recommend repair of railing and consider nailing down some of the wooden planks that are coming loose.

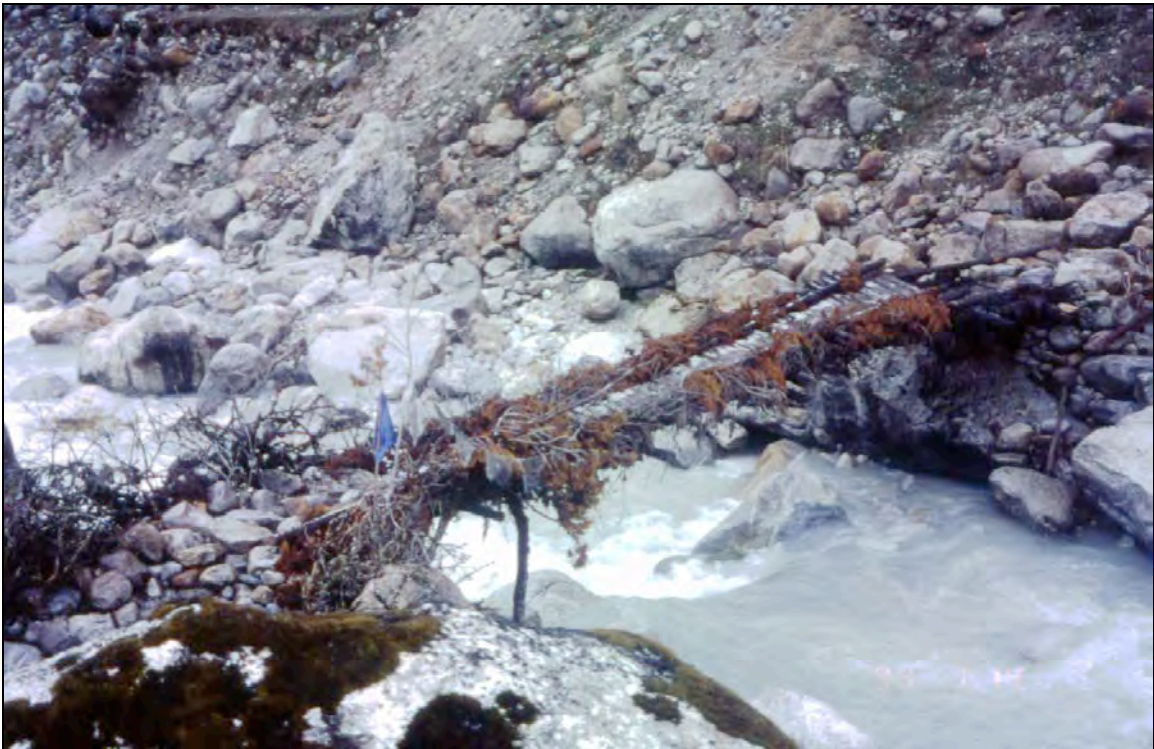
Number: 31	Stream: Simbuwa Khola	4 May 2001
Lat. 27 deg. 34.075' N	Long. 87 deg. 58.664' E	Elevation: 3750 m
Location	Nargartse, across the river from Tseram.	
Description	Wooden bridge, approximately 15 m long, secured by piled rock . Construction materials include juniper wood, pine branches, and rocks.	
Construction Style	Cantilever- style bridge, constructed of juniper wood.	
Condition	Bridge is old, tilted, uneven, and somewhat bouncy upon crossing. Generally it appears stable, but persons should cross one at a time. If this becomes a popular trekking route, the bridge will need to be improved.	
Possible Hazards	Too much weight could break the middle portion of this bridge away from the sides, especially as one end is not secured by rocks and could potentially uproot.	
Recommended Maintenance	Use levels might require a sturdier bridge.

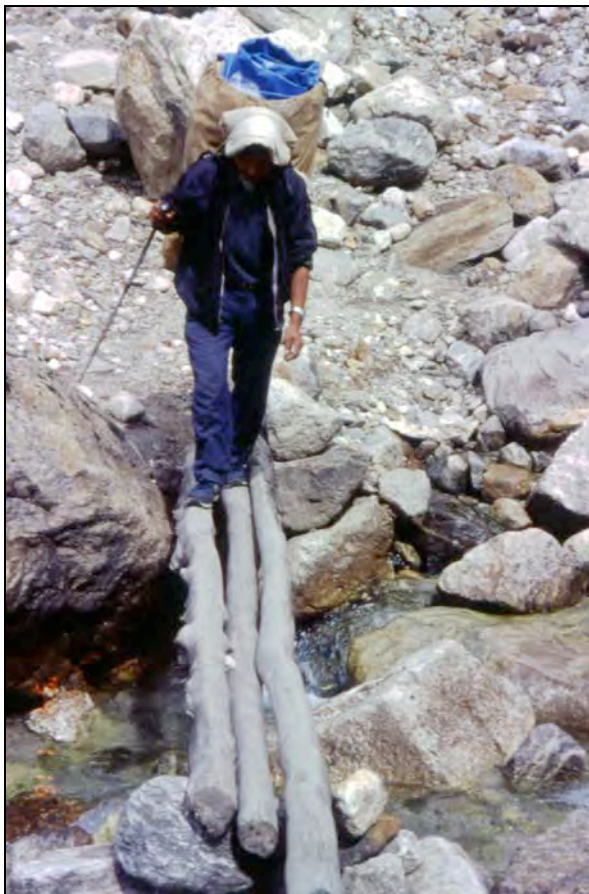
Number: 32	Stream:	6 May 2001
Lat. 27 deg. 34.523' N	Long. 87 deg. 58.868' E	Elevation: 4000 m
Location	Located about 30 min north of Tseram in eroded stream gully.	
Description	Wooden log bridge, approximately 10 ft long and 1.5 ft wide, made of three logs resting on rocks.	
Construction Style	Temporary log bridge.	
Condition	Condition is stable and good, but when stream rises, it will likely be washed away.	
Possible Hazards	Logs are slippery when wet and may also break under heavy weight.	
Recommended Maintenance	None observed.

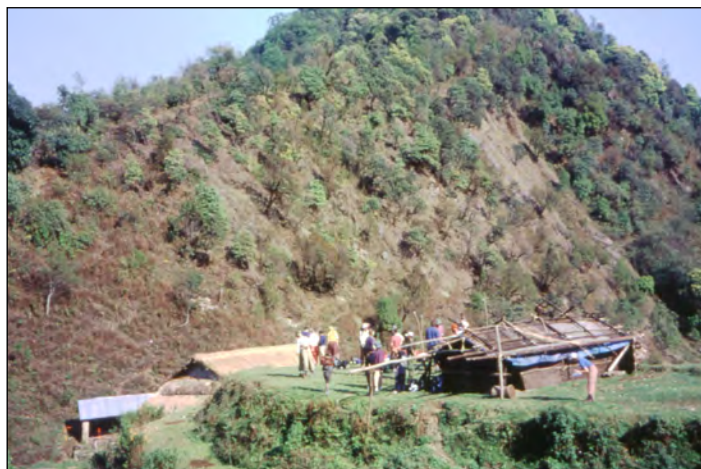
Structures	One small shed suitable for sleeping. Nearby houses, no facilities dedicated to trekking groups
Facilities for Staff	Space sufficient for community tent, kitchen tent. Nearby residences, one of which damaged by wind storm
Campsite Condition	Grazed pasture at the crest of a pass with little evidence of use by trekking groups. Leech prone. Wedge-shaped hilltop with extra tent space on abandoned terraces.
Assets	Excellent views of Kangchenjunga and surrounding hills
Liabilities	High wind, exposure to lightning. Leeches. Moderate amount of dung present in camping area.
Water Source	Water faucet is located nearby
Trash Disposal	None
Human Waste Disposal	None
Name of Caretaker	None
Maintenance Schedule	None
Season of Use	Available year-round, likely very wet during monsoon
Environmental status	No surface water to pollute, surrounding forests are degraded, heavy use could impede recovery
Cost per night	No charge

Other Uses	Once terraced for farming. Now the land is used for grazing.
Photographs	1-1: panoramic; 1-2: north-facing terrace okay for two tents; 1-3: main camping area; 1-4: south-facing ledge for toilet tents.

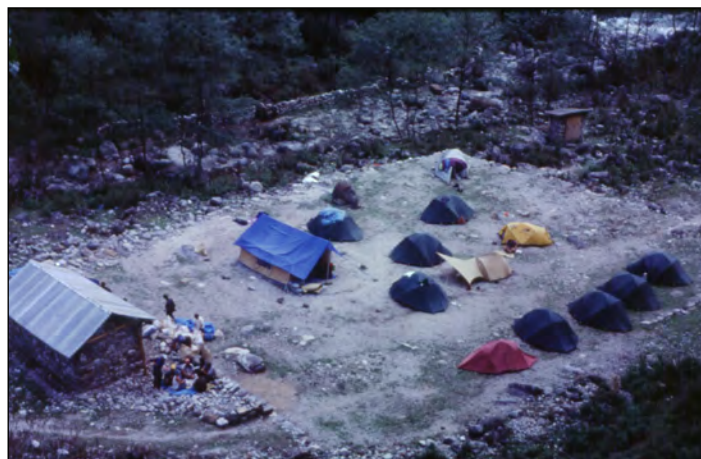
Number: 2	Place: Yamphudin River Camp #1	Date: 5/28/01
Location:	27 deg 27.048 N, 87 deg. 54.475 E, 1680 m elevation

Structures	One cooking and sleeping shelter, 6x4 m. One toilet shed, 3x5 m
Facilities for Staff	Cooking shelter has galvanized steel roof and sturdy rock walls, open on one side. Built 6 months ago. Sleeps at least 7. Porters find shelter in nearby town
Campsite Condition	Bare earth, porous and gravelly. Not well-suited to camping. Grass would be preferable.
Assets	Convenient access to town, river. Campsite is flat and large. Good view of encircling hills. Fewer leeches.
Liabilities	Bare soil is dusty and uneven. Lack of shade.
Water Source	Adjacent to Kabeli Khola
Trash	No
Human Waste Disposal	Toilet located at edge of camp, about 10 m from nearest surface water. Toilet was locked and out of service during our visit. Area between camp and Kabeli Khola is used as a latrine. Ample space for toilet tents

Name of Caretaker	Yamphudin Mother's Group maintains campsite, provides toilet
Maintenance Schedule	Maintained once at the beginning and once at the end of the fall trekking season. Maintenance includes trash pick-up, leveling.
Season of Use	Available year-round
Environmental status	Good. Little evidence of trash. No vegetation present. Potential problem with human waste disposal near Kabeli Khola. Should be directed away from river. Toilet holes from previous trekking groups not well-covered.
Cost per night	100 Rs/night for cooking shelter, 100 Rs/night for community tent, 25 Rs/night each member tent. 100 Rs extra to use cooking shelter at midday.
Other Uses	No
Photographs	1-8: View of camp; 1-9: cooking shed; 1-10: Toilet

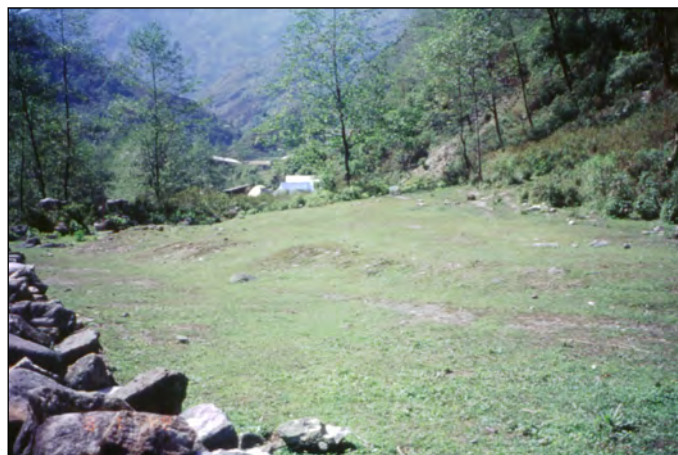
Number: 3	Place: Yamphudin River Camp #2	Date: 5/28/01
Location:	27 deg 27.008' N, 87 deg. 54.441' E, 1660 m elevation

Structures	Access to toilet adjacent to Yamphudin River Camp #1, 50 m away.
Facilities for Staff	None on site. Lodging available in town, 300 m away
Campsite Condition	Site is grassy but poorly drained, sloping over much of the area. Some trash on ground. Trash pit located across rock wall
Assets	Close to stream, further from town center, hence quieter
Liabilities	Many leeches, poorly drained after rain, sloping ground. Potential to pollute adjacent Kabeli Khola. Many rocks interfere with tent sites. Needs water diversion channel. Access trail very muddy.
Water Source	Kabeli Khola 20 m away
Trash Disposal Facilities	Trash pit located adjacent to camp, between camp and river

Human Waste Disposal	Toilet 50 m away at Yamphudin River Camp #1. Seasonal river channel adjacent to camp is used as a latrine. Trekking groups dig own toilet pits.
Name of Caretaker	Yamphudin Mother's Group maintains campsite
Maintenance Schedule	Maintained once at the beginning and once at the end of the fall trekking season. Appears to be maintained less than Yamphudin River Camp #1.
Season of Use	Available year-round
Environmental status	Trash pit is poorly situated too close to river and too close to camp. Campsite was littered at the time of our visit.
Cost per night	Probably same as Yamphudin River Camp #1:  100 Rs/night for cooking shelter, 100 Rs/night for community tent, 25 Rs/night each member tent. 100 Rs extra to use cooking shelter at midday
Other Uses	Perhaps some limited grazing

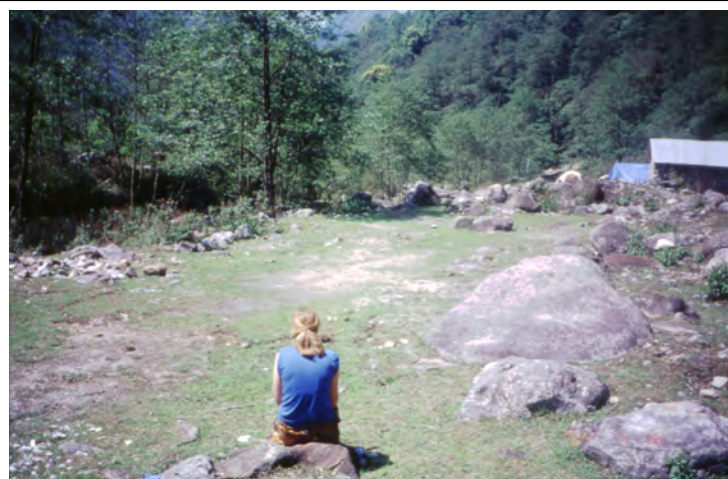
Number: 4	Place: Yamphudin Village Campsite (Town)	Date: 4/27/01
Location:	27 deg 064' N, 87 deg. 54.510' E, 1675 m elevation

Structures	One cooking/sleeping shed is located nearby. This also services Yamphudin River Camp #1
Facilities for Staff	Lodging in town, located 50 m from camp
Campsite Condition	Ground is uneven with many large rocks. Previous tent use indicated by bare gravel amidst grassy areas.
Assets	Flat and partially shaded. Fairly close to town and close to river
Liabilities	No toilet, trekking groups must provide their own. No trash disposal. Rocks reduce the number of available tent sites.
r Source	Seasonal stream adjacent to camp. Kabeli Khole 250 m away.
Trash Disposal Facilities	No
Human Waste Disposal	No
Name of Caretaker	Yamphudin Mother's Group maintains campsite

Maintenance Schedule	Maintained once at the beginning and once at the end of the fall trekking season.
Season of Use	Available year-round
Environmental status	This is an overflow campsite for Yamphudin River #1. If tourism increases to the level where this camp gets consistent use, then cooking shelter and toilet facilities will be needed.
Cost per night	Probably same as Yamphudin River Camp #1:  100 Rs/night for cooking shelter, 100 Rs/night for community tent, 25 Rs/night each member tent. 100 Rs extra to use cooking shelter at midday
Other Uses	Perhaps some limited grazing
Photographs	1-14: SW corner; 1-15: NE corner

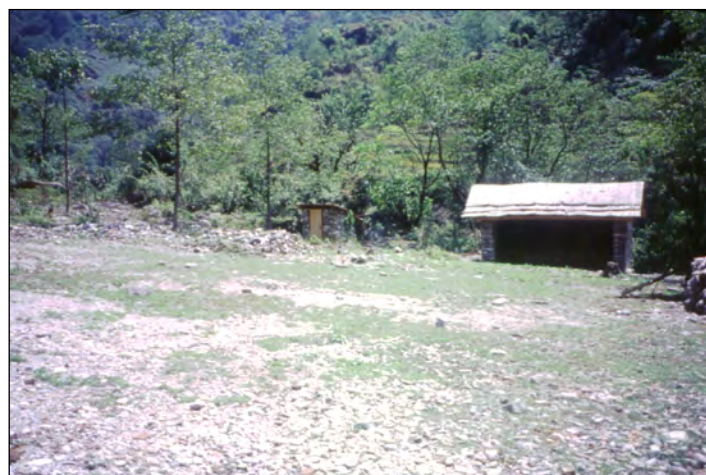
Number: 5	Place: Yamphudin Village Campsite (Bridge)	Date: 4/27/01
Location:	27 deg 27.141 N, 87 deg. 54.654' E, 1712 m elevation

Structures	One cooking shelter with open front and thatched roof, approx 4.5 x 6 m. One toilet structure, approx 3 x 3 m.
Facilities for Staff	Cooking shelter, lodging in town, about 400 m from camp
Campsite Condition	Good. Tent sites are in an open area but shade is available near the cooking shelter. Easy river access for washing, but river too swift for swimming.
Assets	River access, expansive flat area, near town (but not too near). Nicely built stone wall with shade.
Liabilities	Camping surface gravel, very stony in some places. New site, not well vegetated.
Water Source	This campsite has a faucet and is also accessible to the Kabeli Khola
Trash Disposal Facilities	Trash pit at the camp

Human Waste Disposal	Toilet
Name of Caretaker	Yamphudin Mother's Group maintains campsite, provides key to toilet
Maintenance Schedule	Maintained once at the beginning and once at the end of the fall trekking season. Maintenance includes trash pick-up, level gravel.
Season of Use	Available year-round
Environmental status	Campsite was littered with trash at the time of our visit. Trash pit is located too close to Kabeli Khola,
Cost per night	100 Rs/night for cooking shelter, 100 Rs/night for community tent, 25 Rs/night each member tent. 100 Rs extra to use cooking shelter at midday.
Other Uses	Grazing? Sports?
Photographs	1-16: NE Corner; 1-17: NW Corner; 1-18: SW Corner

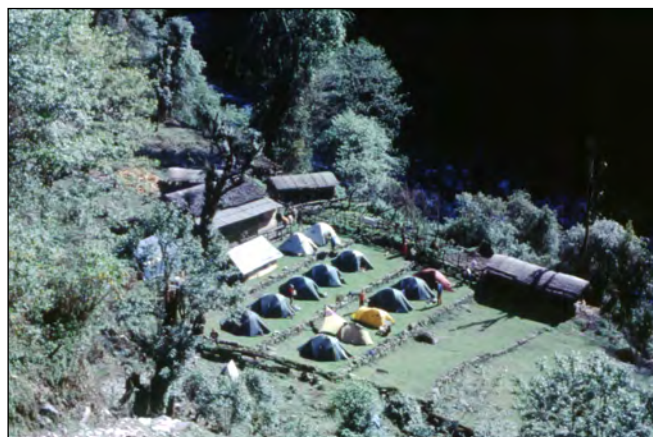
Number: 6	Place: Omje Khola	Date: 5/01/01
Location:	27 deg 28.957' N, 87 deg. 54.751' E, 2360 m elevation

Structures	Teahouse/Shop/Caretaker residence located at north (upper) end of campsite. Large porch, building and sheds in good condition. Two shelters for staff and porters located along east (river) edge of camp. These are wood, three-sided with fire pit and earthen floor. Reasonable condition
Facilities for Staff	Two open-sided shelters in reasonable condition, fires used for cooking. Staff can also sleep in caretaker's residence.
Campsite Condition	Campsite is well-maintained. Consists of 6 terraced plots that are meadowed. Site is well-drained. Animals kept away from camp in area above caretaker's residence.
Assets	Attractive location near dense forest, site well-drained, well-maintained.
Liabilities	Toilet improperly located near stream, leeches in wet season.

Water Source	Faucet near camp, stream 3 minutes walk from camp.
Trash Disposal	Deep (1.8 m) trash pit located at southern end of campground, about 5 m from toilet
Human Waste Disposal	Toilet needs to be improved. No pit, waste flows down into a seasonal stream channel 2-3 meters from structure.
Name of Caretaker	Changra Gurung lives on site during trekking season, in Yamphudin at other times.
Maintenance Schedule	Maintained by Changra Gurung during trekking season, about 6 months/year.
Season of Use	September-December, March-May. Closed winter and summer
Environmental status	Camp is environmentally friendly except that the toilet is improperly located. It needs a bit and should be located where it won't pollute the stream.
Cost per night	100 Rs night for community tent, 25 Rs/night member tent. This is private land, profits go to owner
Other Uses	Limited grazing, land once farmed now more profitable to maintain as campsite.

Photographs	1-30: looking down on camp from trail to Lassi Bhanjyang, 8AM; 1-31: looking SW from above camp, 8 AM; 1-32: toilet structure

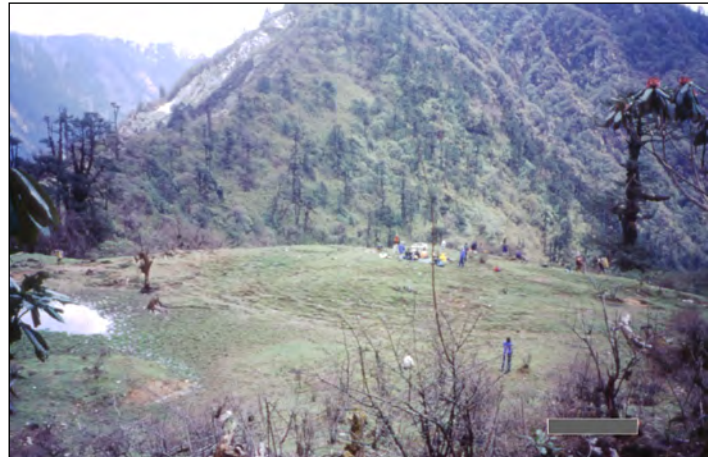
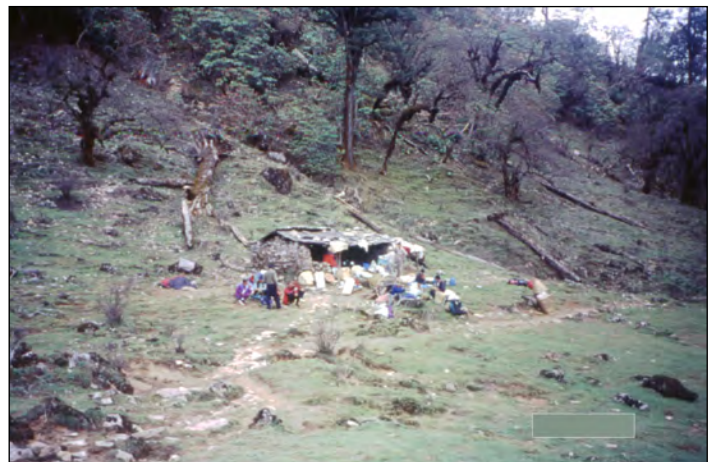
Number: 7	Place: Lasiye Bhanjyang	Date: 5/2/01
Location:	27 deg 29.895' N, 87 deg. 54.832' E, 3415 m elevation

Structures	3-sided, rock-walled structure with wooden shingle roof, shingles anchored by stones. Adjacent stall constructed of wood can be used for cooking or shelter.
Facilities for Staff	One open-sided stone structure and one wooden stall as described above
Campsite Condition	Site not well-maintained. Trash scattered around site, no toilet facilities. Infrequently occupied.
Assets	Convenient flat place at top of pass. Good views of Jannu. Rich <i>Abies-Rhododendron</i> forest
Liabilities	Poorly drained, limited shelter, probably lacks water in dry season. Some lightning hazard. Much dung. Trail passes directly through the camp. Inadequate shelter for staff during severe weather.
Water Source	Seasonal rivulets NW of camp, puddles used by livestock. Subject to water shortage in dry season.

Trash Disposal Facilities	None, some other groups have tried to bury trash with varying degrees of effort.
Human Waste Disposal	No Facilities
Name of Caretaker	None
Maintenance Schedule	None
Season of Use	Mainly fall and spring. Probably by local herders during summer.
Environmental status	Several negative impacts observed here: no waste disposal, previous groups have left trash, much trenching around tent sites, forest has been cut in vicinity of camp.
Cost per night	No charge
Other Uses	Used as a grazing pasture
Photographs	1-33: porter shelter, 11 AM; 1-34: from S end, looking NE, 11:15 AM, 35: from S end, looking NW, 11:15 AM.

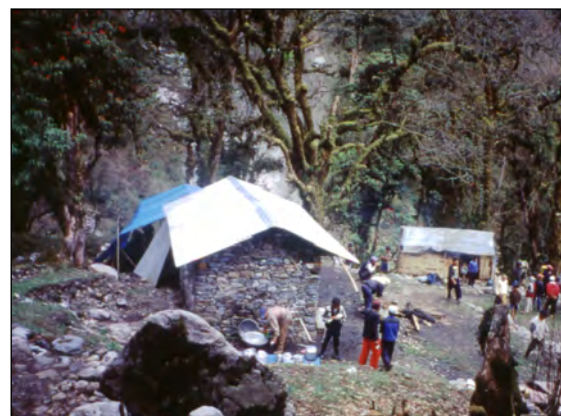
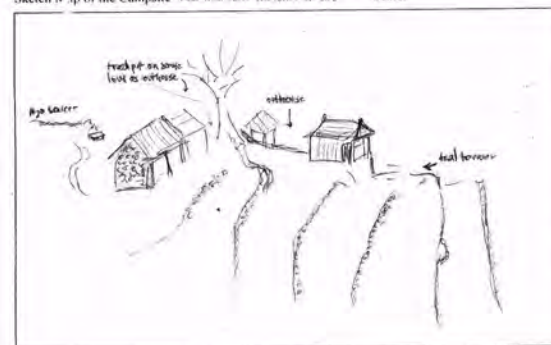
Sketch Map of the Campsite View from south (looking up the valley) Scale:

Structures	(1) Cooking shelter: stone with metal roof, newly constructed, adjacent shed with roof of plastic sheeting. (2) Teashop: recently built, makeshift wood structure with plank floor and fire pit. (3) Toilet: Stone and wood construction with metal roof and door
Facilities for Staff	Cooking shelter and wooden teashop are available. Numerous caves a few hundred meters up valley have provided shelter for porters until the campsite was improved last year. These are still used.
Campsite Condition	Good. Camp includes five rock-walled terraces for tents for tents, structures as noted above, faucet near kitchen. Trash pit. During fall, this campsite is inadequate for the volume of trekking traffic.
Assets	Scenic location, well-maintained site away from river. Excellent birding in adjacent forest. Snacks available at tea-house.
Liabilities	Crowded during high season

Water Source	Faucet 4 m from cooking shelter brings clear water from small tributary stream located NE of camp. River 3 minutes walk downhill from camp
Trash Disposal Facilities	Trash pit in NW corner of camp, about 2 m from toilet. 1.6 m deep, lined with rock on two sides.
Human Waste Disposal	Stone and wood toilet with metal roof located in NW corner of camp. Adequate distance (50 m) from river.
Name of Caretaker	Lapsang, a resident of Yamphudin. Structures (cook shelter, toilet, trash pit) built w/ support of Yamphudin Mother's Group.
Maintenance Schedule	Sporadic, during trekking season
Season of Use	March-June, September-December. Caretaker lives on site for 4-5 months/year.
Environmental status	Good. Camp is well-positioned on a slope above the river. Extensive grading provides terraced tent sites. Convenient stairs link terraces. Toilet ight require a deeper pit, some forest loss due to staff collected wood from around the camp. Some of the caves are littered.

Cost per night	Currently no charge to camp. This is currently under evaluation. Caretaker makes profit with teashop
Other Uses	Grazing nearby
Photographs	1-36: Camp from NE, 4PM; 2-1: Structures from NE, 4PM; 2-2: Toilet and trashpit, 4 PM

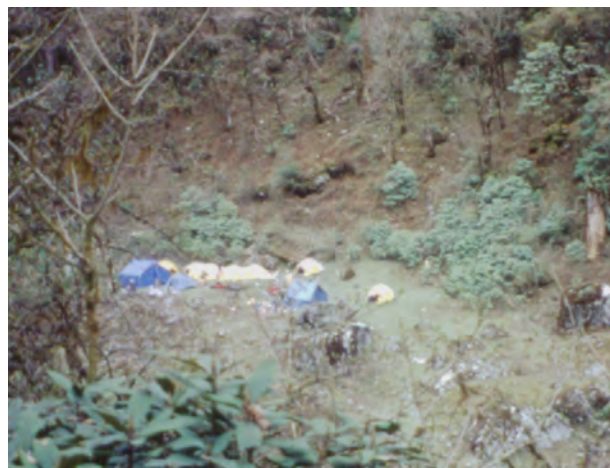
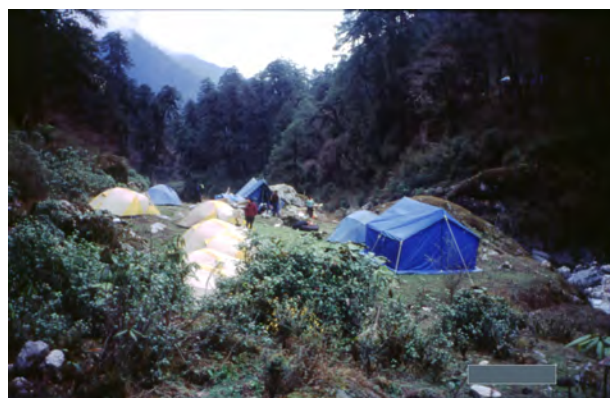
Torongdon Overflow Sketch

Structures	None
Facilities for Staff	None, porters may use shelter at campsite across river, or nearby caves traditionally used for shelter.
Campsite Condition	Undeveloped overflow campsite. Level meadow with prodigious amounts of goat dung
Assets	Level surface
Liabilities	Campsite covered in a thick layer of goat dung.
Water Source	Camp located near Simbuwa Khola, water has glacial till. Clear tributary stream also nearby
rash Disposal Facilities	None
Human Waste Disposal	None
Name of Caretaker	None
aintenance Schedule	Not maintained
Season of Use	Only used during peak trekking season (October-November and May) when main site is occupied.
Environmental status	Little use, no facilities. Site already degraded by livestock
Cost per night	---
Other Uses	Domestic livestock grazes and sleeps here
Photographs	2-3: across river from east, 4 PM; from NW, 4 PM

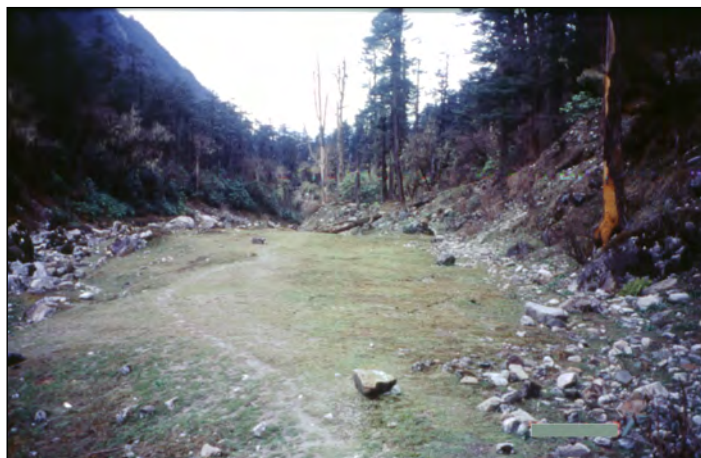
Number: 10	Place: Anda Phedi	Date: 5/3/01
Location:	27 deg 33.148' N, 87 deg. 56.747' E, 2120 m elevation

Structures	None
Facilities for Staff	None at the campsite. Teahouse and lodge located 20 minutes' walk upvalley
Campsite Condition	Infrequently used for camping. Unimproved meadow, poorly drained in some locations. Flat area to pitch tents, away from trail, near Simbuwa Khola
Assets	Scenic, away from trail, near river.
Liabilities	Poorly drained
Water Source	Simbuwa Khola 50 m away with seasonal channels closer to camp. Simbuwa has glacial till, but drinkable. Clear tributary streams may be nearby.
Trash Disposal Facilities	None
Human Waste Disposal	None
Name of Caretaker	Prem Chetten Lama stays in nearby Anda Phedi Lodge. Yamphudin Mothers Group responsible for maintenance here.

Maintenance Schedule	Sporadic, by caretaker and Mothers Group
Season of Use	This area is used occasionally by trekking groups during spring and fall. Grazers use this area in the summer and early fall. Valley is vacated during winter.
Environmental status	Little human impact except for three fire rings at periphery of site.
Cost per night	Kitchen and community tents Rs 150/night. Member tents Rs 20/night. Charge for staff firewood.
Other Uses	Chauri and yak graze here
Photographs	2-6: taken from SW corner, 11 AM

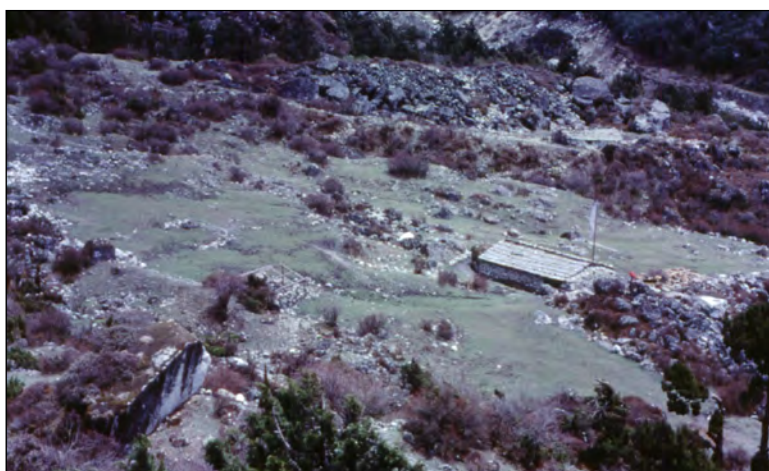
Number: 14	Place: Tseram Camp "C"	Date: 5/5/01
Location:	27 deg 34.181' N, 87 deg. 58.616' E, 3810 m elevation	
Structures	Tea House and Shelter for yak and chauri.	
Facilities for Staff	Tea House provides limited staff accommodation. Caves nearby.	
Campsite Condition	Small site well-maintained, flat w/ well-drained soil. Adjoining area trash-littered. Toilet area not clean, old toilet pits not well covered.	
Assets	Area west of the teahouse is flat and well suited to camping. Quieter and more secluded than the other two Tseram campsites. Good views.	
Liabilities	Camp is too small for a large trekking group. Site used mainly when the other campsites are full.	
Water Source	Springs and a small stream are located about 50 m from camp. Faucets available at the other two nearby campsites.	
Trash Disposal Facilities	Doko at campsite, trashpit shared with Camp "B."	
Human Waste Disposal	Trekking groups provide their own toilet tents.

Name of Caretaker	Tsering Sherpa, receives Rs 1000/yr from (Yamphudin?) Mother's Group to support campsite maintenance. Lives in teahouse next to Camp "B."	
Maintenance Schedule	Trash is picked up as needed after each group leaves.	
Season of Use	Trekking season: spring and fall. Grazers occupy this area during summer. Vacant during winter.	
Environmental status	Trash, mostly cans and bottles, observed around periphery. Much dung also. Western part is maintained better than the eastern part. Permanent toilet is needed as area where trekking groups put toilet tents is insufficient. Camp located in well-drained site far from river, but near juniper forest. Easy to cut wood illegally from this forest.	
Cost per night	Uncertain, probably Rs 25 per tent per night, regardless of size.	
Other Uses	Livestock grazing, mainly yak and chauri.	
Photographs	2-14: looking east from west corner, about 11 AM

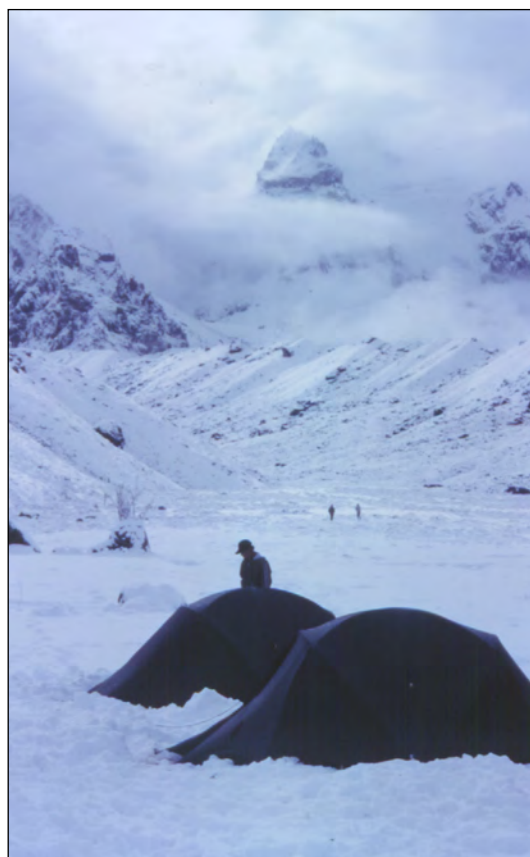
Number: 17	Place: Yarlung	Date: 5/8/01
Location:	27 deg 34.594' N, 87 deg. 59.050' E, 4140 m elevation

Structures	2 stone shelters are located here. One is damaged (roof is half missing), the other has been repaired and includes a covered porch, but the door is locked.
Facilities for Staff	Stone shelter with shingle roof covering half the area, the other half is open
Campsite Condition	Extensive, but most of the camping area is covered in stone and dung. Camp is not maintained. Much trash - old plastic sheeting, shoes, paper and plastic. Shelter is full of trash.
Assets	Large area near shelter with water nearby. Spectacular views.
Liabilities	Located near Tseram, which has better campsites. Too far above Torondon for convenient acclimatization, too near Tseram. Moist alpine scrub is vulnerable to groups that do not have sufficient kerosene.
Water Source	Stream located about 20 m below the camp.
Trash Disposal Facilities	None
Human Waste Disposal	None
Name of Caretaker	No caretaker
Maintenance Schedule	No maintenance. Recommend assigning caretaker, repairing hut and cleaning trash if this area is to developed as a comp site.

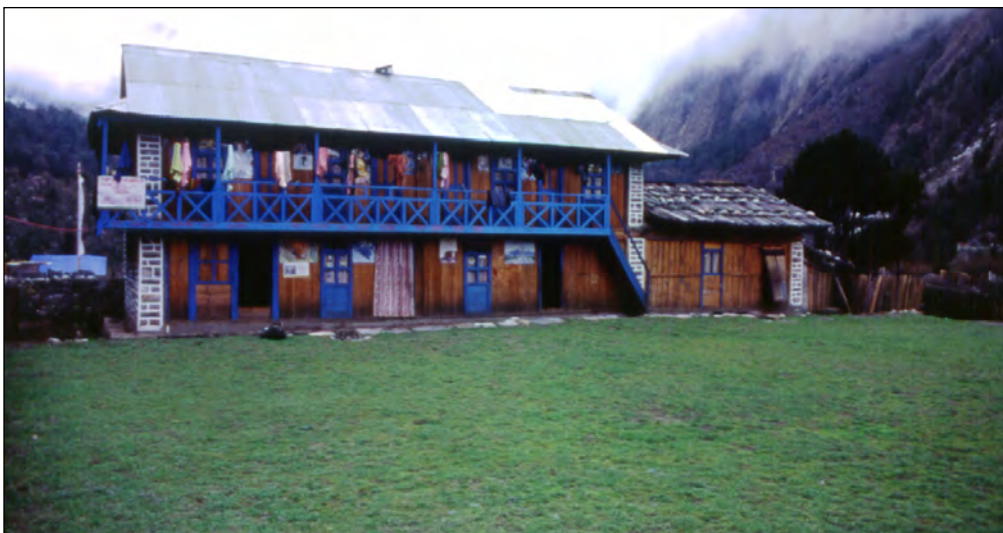
Number: 19	Place: Gunsa Guesthouse	Date: 5/12/01
Location:	27 deg 39.635' N, 87 deg. 56.160' E, 3415 m elevation

Structures	Lodge with kitchen shed, shower stall, two closed-pit toilets.
Facilities for Staff	Available at adjacent lodge and elsewhere in Ghunsa
Campsite Condition	Site is level and offers many amenities. Reasonably clean. Bare ground surface would benefit from better grass cover.

Assets	Pleasant, level campsite with amenities including shower and closed-pit toilets. Secure area, convenient access to shop.
Liabilities	Lack of grass cover. Prone to mud during rainy periods.
Water Source	KCAP water tap located at campsite.
Trash Disposal Facilities	Open pit. When the pit fills, it is covered with soil and a new pit is excavated.
Human Waste Disposal	Closed pit toilets on site
Name of Caretaker	Dandi Sherpa, a resident of Gunsa.
Maintenance Schedule	As needed during the trekking season (spring and fall). Camp also open as needed during summer but few visitors at this time
Season of Use	Camp open all year except for three months during the winter when the residence is vacant.
Environmental status	Reasonable. Site would be improved by grass. Otherwise tends to be muddy. Low-impact technologies include backburner to heat shower water.
Cost per night	Large kitchen tent Rs 150, client tents Rs 25. Caretaker handles the money and controls the profits.

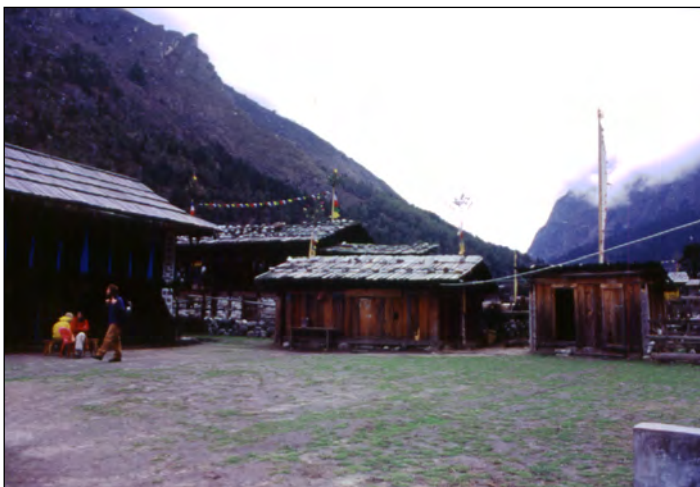
Number: 20	Place: Kanchenjunga Guest House, Ghunsa	Date: 5/3/01
Location:	27 deg 39.684' N, 87 deg. 56.261' E, 3415 m elevation	
Structures	Lodge located behind campsite, includes toilet, dilapidated kitchen shack	
Facilities for Staff	Staff accommodations include lodge, kitchen shack, nearby residences.	
Campsite Condition	Muddy. Campsite needs more grass cover, garbage pit is open so that trash is strewn about the adjoining forest. Camp slopes slightly.	
Assets	Secure and well-contained	
Liabilities	Trash-disposal problem. A more secure trash pit would prevent litter from spreading about.	
Water Source	Good, KCAP-3 faucet located directly down slope from campsite.	
Trash Disposal Facilities	Trash piled near camp. A more secure trash pit is needed.	
Human Waste Disposal	Closed-pit toilet.	
Name of Caretaker	D.C. Sherpa is the caretaker/owner. He was away from Ghunsa at the time of our survey.	
Maintenance Schedule	Not known

Season of Use	Not known	
Environmental status	Reasonable, except for trash disposal problem	
Cost per night	Not known	
Other Uses	Not known	
Photographs	Chris' camera #13

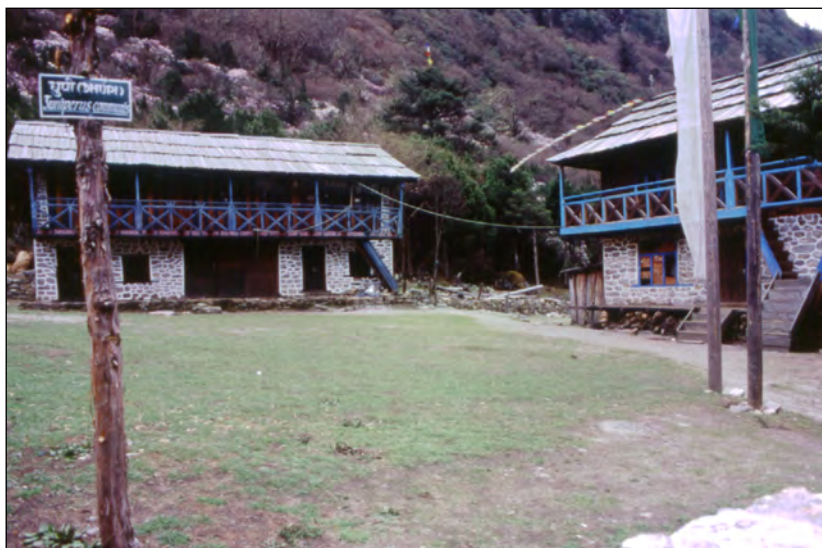
Number: 21	Place: Yak Hotel and Lodge, Ghunsa	Date: 5/12/01
Location:	27 deg 39.700' N, 87 deg. 56.138' E, 3415 m elevation	
Structures	Lodge, open pit toilet	
Facilities for Staff	Lodge adjacent to campsite, other lodges nearby in Ghunsa	
Campsite Condition	Clean but need maintenance. Uneven surface, broken fence.	
Assets	Clean. Good view of village, near river. Shower with water heated by back burner in adjacent lodge.	
Liabilities	Uneven surface for camping, need to remove rocks, would benefit from more permanent drainage	
Water Source	KCAP water tap #5 located next to site	
Trash Disposal Facilities	Needs to be developed at this campsite	
Human Waste Disposal	Open pit toilet located in a structure separate from the lodge, design could be improved.	
Name of Caretaker	Choyme Sherpa, "Kanchsar"	
Maintenance Schedule	Year-round maintenance as needed. Campsite was quite clean at the time of our visit.

Season of Use	All year, mostly during the trekking seasons	
Environmental status	Good. Some drainage problems, toilet adequate but could be improved by covering the pit. Needs better access to trash disposal facility.	
Cost per night	Kitchen tent Rs 150, small tents Rs 25/night	
Other Uses	None	
Photographs	Chris #14

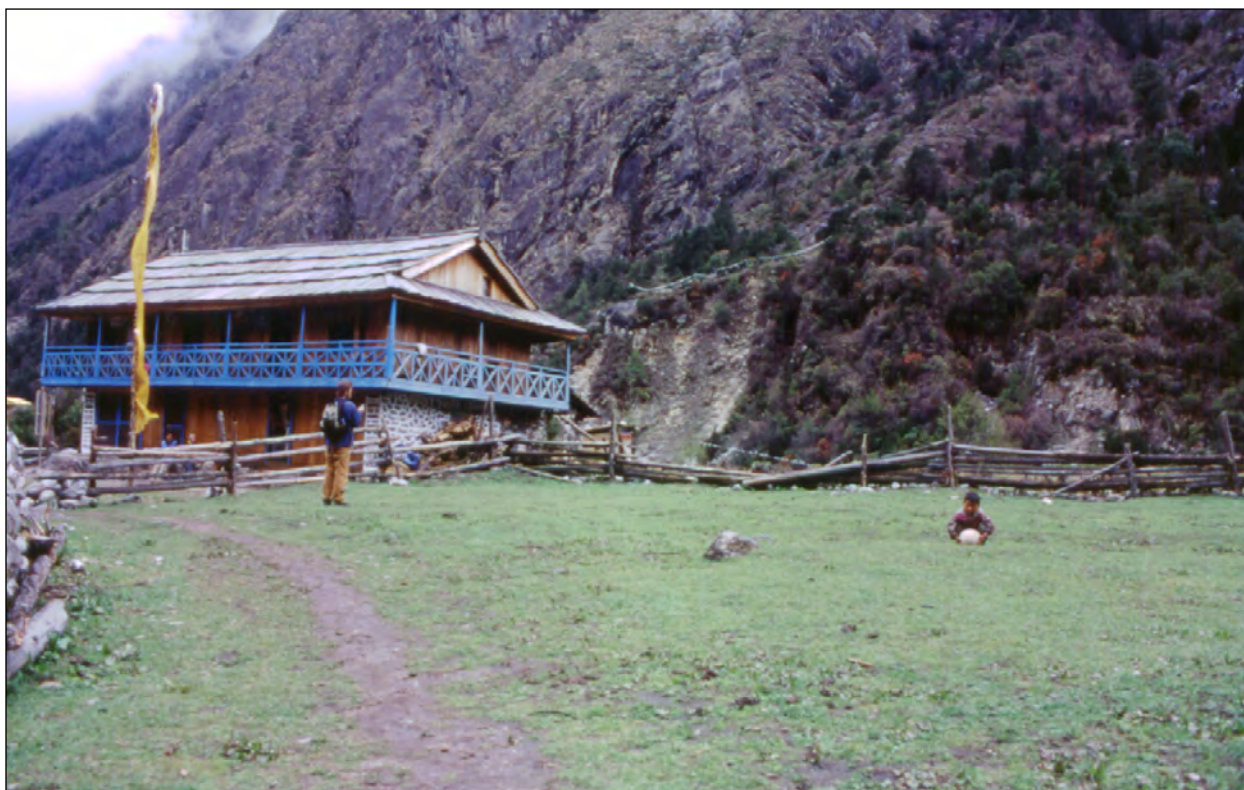
Number: 22	Place: School Camp West, Ghunsa	Date: 5/12/01
Location:	27 deg 39.---' N, 87 deg. 56.---' E, 3415 m elevation	
Structures	Cooking shelter	
Facilities for Staff	Cooking shelter, or arrange lodging in private homes in Ghunsa.	
Campsite Condition	Rocky, uneven surface. Minimal facilities.	
Assets	Secluded, away from town. Very near trails to Mrigin La and Yamtori Valley	
Liabilities	Uneven surface, minimal facilities, little security compared to other Ghunsa sites. Near School. Camp located adjacent to main trail, much through traffic.	
Water Source	Clear stream is located on moraine-slope behind camp. Ghunsa village faucets nearby.	
Trash Disposal Facilities	None	
Human Waste Disposal	None	
Name of Caretaker	Dandu Sherpa	
Maintenance Schedule	Caretaker spends 9 months/year in Ghunsa. During this time he looks after the campsite.	
Season of Use\	Open all year except three months in winter.	
Environmental status	As there is no permanent toilet, trekking groups should be advised to site toilet tents away from the stream. Solar showers have been installed at the school to raise money and provide service to trekkers. Not clear whether these are currently in operation.

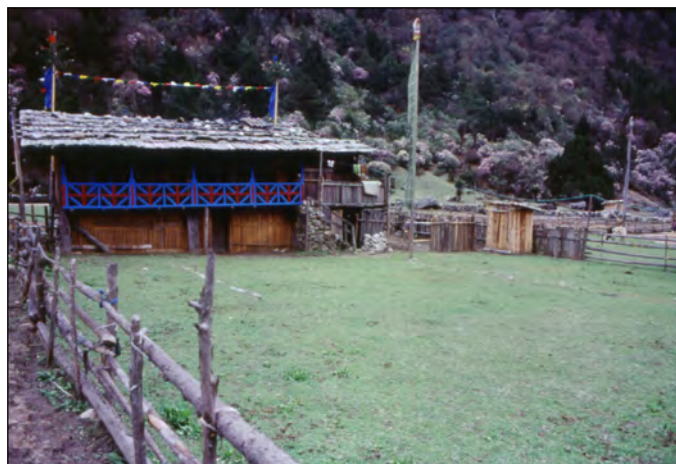
Number: 27	Place: Yak Hotel, Kembachen	Date: 5/14/01
Location:	27 deg 44.202' N, 87 deg. 58.306' E, 4100 m elevation	
Structures	One building onsite serves as a shop/lodge/teahouse. Several similar structures nearby. Closed pit toilet located near stream.	
Facilities for Staff	Yes, in lodge.	
Campsite Condition	Campsite is small but well-maintained, grassy and clean	
Assets	Grassy, free of litter. Secure.	
Liabilities	Congested, with several other campsites and lodges located immediately adjacent. Too small for a large group.	
Water Source	Stream nearby. Stream may be clear or muddy, depending on snowmelt in the upper catchment.	
Trash Disposal	Compost pile near shop, open pit community dumpsite nearby	
Human Waste Disposal	Closed pit toilet next to stream - recommend moving it further from the stream. Should be located on hillside.	
Name of Caretaker	Chumbe Sherpa	
Maintenance Schedule	Camp is cleaned according to need

Season of Use	Trekking season. Vacant during winter	
Environmental status	<p>During the past 4 years, many lodges have been built in the meadow at Kembachen. However there are several reasons why the proliferation of lodges in this area should be controlled. (1) meadow habitat is ecologically fragile and poorly drained, (2) meadow locations are probably colder than the adjoining hillsides where people have traditionally lived, (3) Good grazing land is being replaced by construction. (4) Human impact is highly visible here.</p> <p>This lodge and camp is located near the south end of the valley, alongside a clear stream. Sensitive locations such as this should be subject to an environmental impact assessment before lodge construction is allowed to proceed. A nearby hillside location might have been more appropriate.</p>	
Cost per night	Large tents Rs 150, Small tents Rs 20	
Other Uses	Yak and Chauri grazing

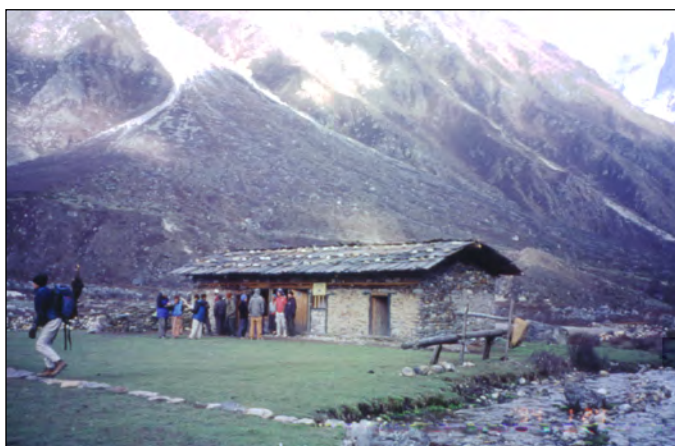
Number: 28	Place: "Good Camp and Kitchen," Kembachen	Date: 5/14/01
Location:	27 deg 44.221' N, 87 deg. 58.305' E, 4100 m elevation	
Structures	Kitchen and small space for trekking staff	
Facilities for Staff	Kitchen and shelter adjacent to kitchen, plus adjoining buildings	
Campsite Condition	Good, well-tended campsite: clean, flat and grassy. No toilet or garbage bins on-site, but both are available nearby	
Assets	Secure, flat, grassy	
Liabilities	Small. Lack of sanitary facilities.	
Water Source	Stream nearby. Stream may be clear or muddy, depending on snowmelt in the upper catchment.	
Trash Disposal Facilities	None	
Human Waste Disposal	None	
Name of Caretaker	N. Sherpa	
Maintenance Schedule	Lodge closed during our visit. Open during trekking season.	
Season of Use	Trekking season. Now that at least 8 lodges and camps have been built at Kembachen, it is likely that the smaller facilities are only used as overflow sites during height of trekking season.

Environmental status	<p>During the past 4 years, many lodges have been built in the meadow at Kembachen. However there are several reasons why the proliferation of lodges in this area should be controlled. (1) meadow habitat is ecologically fragile and poorly drained, (2) meadow locations are probably colder than the adjoining hillsides where people have traditionally lived, (3) Good grazing land is being replaced by construction. (4) Human impact is highly visible here.</p> <p>This lodge and camp is located near the south end of the valley, alongside a clear stream. Sensitive locations such as this should be subject to an environmental impact assessment before lodge construction is allowed to proceed. A nearby hillside location might have been more appropriate</p>	
Cost per night	Don't know, caretaker absent	
Other Uses	Grazing, lodge used for storage in off-season	
Photographs	2: 31
