***Forest and Infrastructure in Kangchenjunga Conservation Area:  
A Catalog of Images, Spring 2001-2002***

Chris Carpenter, Val Stori, Laxmi Dewan, students and staff of  
Wildlands Studies Nepal Program, 2001 (spring) and 2002 (spring)

in cooperation with  
World Wildlife Fund, Nepal.

October 19, 2002

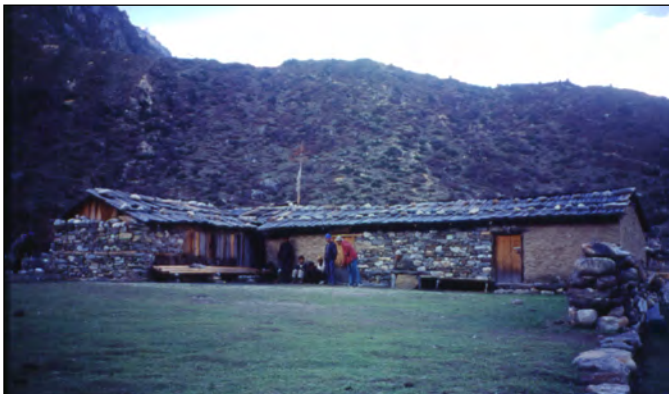
Number: 29	Place: Himalayan Hotel and Shop, Kembachen	Date: 5/14/01
Location:	27 deg 44.229' N, 87 deg. 58.295' E, 4100 m elevation	
Structures	Shelter for staff, wood storage shed, "hotel" with no beds	
Facilities for Staff	Lodge has several rooms that could serve as shelter	
Campsite Condition	Flat, grassy but small	
Assets	Great views. Large open area available to NW.	
Liabilities	Congested with several other lodges adjacent.	
Water Source	Stream nearby. Stream may be clear or muddy, depending on snowmelt in the upper catchment.	
Trash Disposal Facilities	Trash pit on site	
Human Waste Disposal	No. Trekking groups provide their own toilet tents.	
Name of Caretaker	There is a caretaker, but he was unable to speak during our visit.	
Maintenance Schedule	Yes, as needed? Camp closed and under repair during our visit.	
Season of Use	Trekking season. Mainly fall, some use in spring. Vacant in winter	
Environmental status	<p>During the past 4 years, many lodges have been built in the meadow at Kembachen. However there are several reasons why the proliferation of lodges in this area should be controlled. (1) meadow habitat is ecologically fragile and poorly drained, (2) meadow locations are probably colder than the adjoining hillsides where people have traditionally lived, (3) Good grazing land is being replaced by construction. (4) Human impact is highly visible here.</p> <p>This lodge and camp is located near the south end of the valley, alongside a clear stream. Sensitive locations such as this should be subject to an environmental impact assessment before lodge construction is allowed to proceed. A nearby hillside location might have been more appropriate.</p>

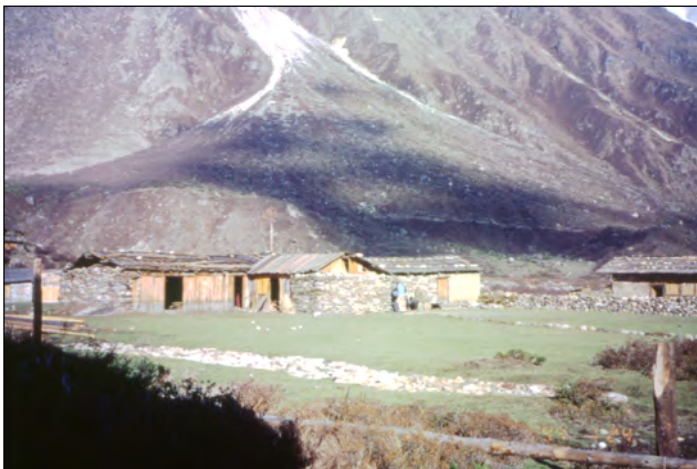
Number: 30	Place: Hotel Junu	Date: 5/14/01
Location:	27 deg 44.238' N, 87 deg. 58.318' E, 4100 m elevation	
Structures	Shop/Lodge with shower-shed attached, located in a large meadow.	
Facilities for Staff	Yes, shelter for trekking staff available in lodge.	
Campsite Condition	Expansive flat, grassy area	
Assets	Good views, lots of space	
Liabilities	Poorly drained, cold in fall (due to meadow-bottom location), much dung, not secure.	
Water Source	Stream runs through meadow	
Trash Disposal Facilities	Trash pits (now covered) have been established in the meadow	
Human Waste Disposal	No permanent toilet. Trekking groups provide own toilet tents.	
Name of Caretaker	There is one, but lodge closed at the time of our visit.	
Maintenance Schedule	Probably, but closed at the time of our visit.	
Season of Use	Only during the high season, probably as an overflow site	
Environmental status	<p>During the past 4 years, many lodges have been built in the meadow at Kembachen. However there are several reasons why the proliferation of lodges in this area should be controlled. (1) meadow habitat is ecologically fragile and poorly drained, (2) meadow locations are probably colder than the adjoining hillsides where people have traditionally lived, (3) Good grazing land is being replaced by construction. (4) Human impact is highly visible here.</p> <p>This lodge and camp is located near the south end of the valley, alongside a clear stream. Sensitive locations such as this should be subject to an environmental impact assessment before lodge construction is allowed to proceed. A nearby hillside location might have been more appropriate.</p>

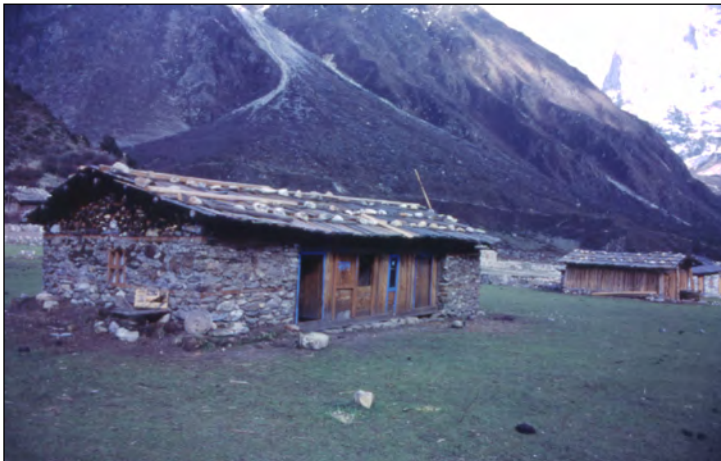
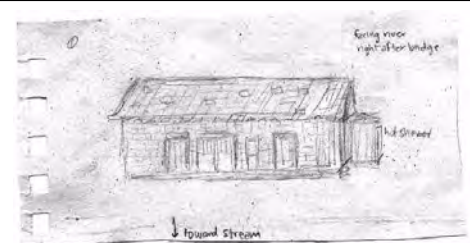
Number: 31	Place: Eat Bal <sup>1</sup> Hotel, Kembachen	Date: 5/3/01
Location:	27 deg 44.229' N, 87 deg. 58.333' E, 4100 m elevation

Structures	One small wooden building surrounded by meadow.
Facilities for Staff	Trekking groups could accommodate staff in the lodge.
Campsite Condition	The meadow is clean and little used, however the habitat is also fragile. Heavy use would cause significant ecological degradation.
Assets	Large, flat area. Grassy surface. Excellent views.
Liabilities	Ecologically fragile alpine pasture, probably poorly drained. Colder than surrounding hillsides. Location crowded with other lodges.
Water Source	Clear stream nearby.
Trash Disposal Facilities	Some trash pits have been constructed (and refilled) at adjoining campsites. A community trash pit is located about 200 m away.
Human Waste	Trekking groups must provide their own toilet tents
Name of Caretaker	Unknown, facility was closed and locked during our visit.
Maintenance Schedule	Unknown, if any.
Season of Use	Used by trekking parties as an "overflow" site during busiest season.

Environmental status	<p>During the past 4 years, many lodges have been built in the meadow at Kembachen. However there are several reasons why the proliferation of lodges in this area should be controlled. (1) meadow habitat is ecologically fragile and poorly drained, (2) meadow locations are probably colder than the adjoining hillsides where people have traditionally lived, (3) Good grazing land is being replaced by construction. (4) Human impact is highly visible here.</p> <p>This lodge and camp is located near the south end of the valley, near a clear stream. Sensitive locations such as this should be subject to an environmental impact assessment before lodge construction is allowed to proceed. A nearby hillside location might have been more appropriate.</p>
Cost per night	Unknown. Probably Rs 150/large tent, Rs 25/small tent
Other Uses	Grazing area

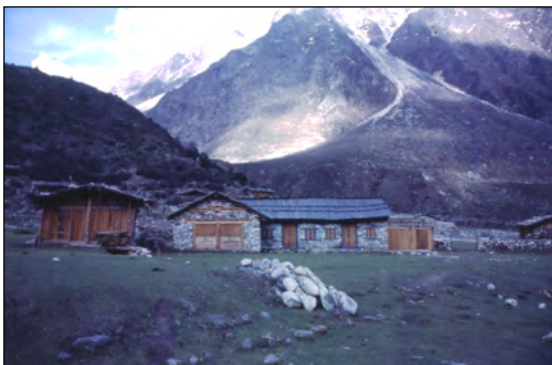
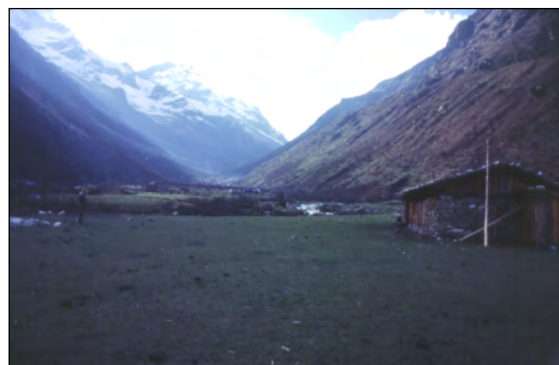
Number: 32	Place: <i>Unnamed Lodge, Kembachen</i>	Date: 5/14/01
Location:	27 deg 44.227' N, 87 deg. 58.337' E, 4100 m elevation

Structures	One lodge, made of stone and wood.
Facilities for Staff	One structure, mentioned above. Others nearby.
Campsite Condition	Meadow is clean and little used, however the delicate nature of this site is such that it probably could not sustain heavy use without ecological degradation.

Trash Disposal Facilities	Old, filled trash pit located in meadow. Practice of digging trash pits in the fragile alpine meadow community should be discouraged. More suitable locations are rocky areas on adjoining slopes.
Human Waste	Trekking groups must provide their own toilet tents
Name of Caretaker	Unknown, Facility closed and locked during our visit.
Maintenance	Unknown, if any
Season of Use	Probably only during fall
Environmental status	During the past 4 years, many lodges have been built in the meadow at Kembachen. There are several reasons why this should have been controlled. (1) The meadow habitat is fragile, wet, and poorly drained, (2) the meadow is likely colder than the adjoining hillside where people have traditionally lived, (3) Good grazing land has been replaced by construction. (4) Human impact is highly visible here. This lodge and camp, located in the center of the meadow, is one of the most poorly sited. A hillside location would have been more appropriate.

Eastward.

Northward.

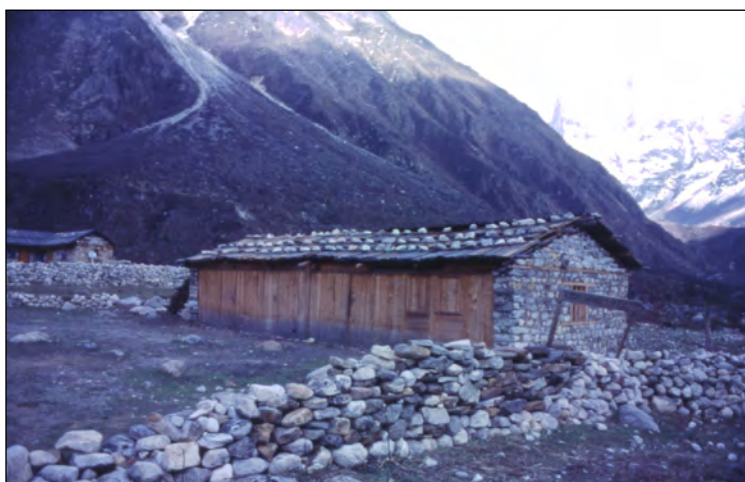
Number: 33	Place: Buddha Trekking Camp, Kembachen	Date: 5/14/01
Location:	27 deg 44.217' N, 87 deg. 58.374' E, 4100 m elevation	
Structures	Stone and wood lodge with shed and open pit toilet	
Facilities for Staff	Lodge, as mentioned	
Campsite Condition	Campground, enclosed by a stone wall, is uneven	
Assets	Secure, walled location. Away from fragile meadow. Site, slightly higher and better-drained, is more appropriate for camping than nearby meadow sites.	
Liabilities	Rocky site.	
Water Source	Stream nearby.	
Trash Disposal Facilities	No disposal facility on site, but this camp is located near the community trash pit. During the trekking season, manager could use a trash basket on site.	
Human Waste Disposal	Open-pit toilet on site	
Name of Caretaker	Unknown, camp and lodge closed during our visit	
Maintenance Schedule	Site is maintained during season.	
Season of Use	Mainly during the peak season in the fall

Environmental status	This site, located in a rocky area near the bottom of the meadow, is more ecologically sound than other places located in the meadow immediately to the north. This site appears to be better drained as well.	
Cost per night	Unknown. Probably Rs 150 for large tent, Rs 25 for small tent	
Other Uses	Lodge used for storage. Yard used seasonally to hold animals.	
Photographs	Chris' 10-8

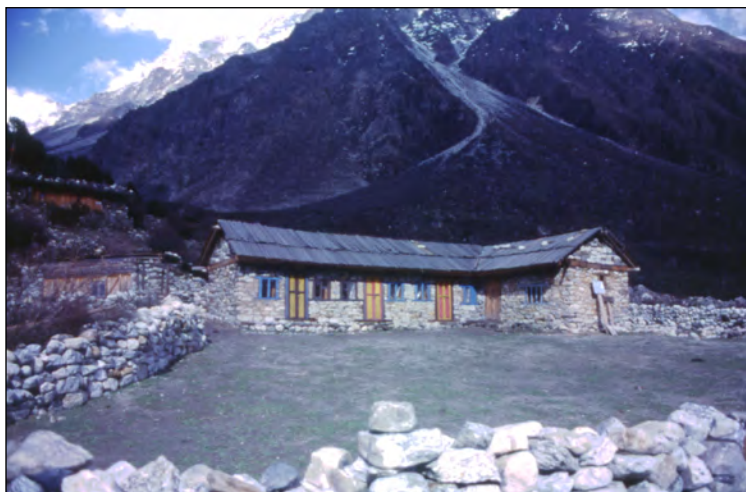
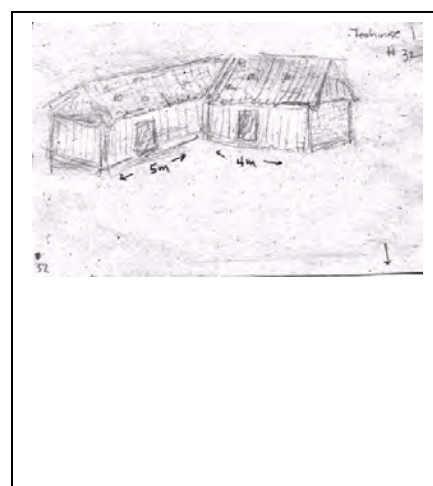
Number: 34	Place: Kanchenjunga Hotel & Shop, Kembachen	Date: 5/14/01
Location:	27 deg 44.225' N, 87 deg. 58.404' E, 4110 m elevation	
Structures	One large, L-shaped building of rock and wood, smaller out-building behind.	
Facilities for Staff	This and other, nearby lodges.	
Campsite Condition	Large campsite, enclosed by a stone wall. Ground rather hard and uneven, but clean. Attractive site	
Assets	Well-drained site, ecologically better-suited to camping than most of the other campsites at Kembachen. Excellent views, secure. Near the old town.	
Liabilities	Sparse grass-cover. Site slopes slightly.	
Water Source	Stream 100 m away. Faucet may be located nearby, uncertain.	
Trash Disposal Facilities	Unknown, probably a trash pit nearby, but we didn't locate it.	
Human Waste Disposal	Closed pit toiled at the camp. Well-designed, not maintained at the time of our visit.	
Name of Caretaker	Unknown, camp and lodge closed during our visit

Maintenance Schedule	Lodge appears well kept up. Site maintained during season.	
Season of Use	Mainly during the peak season in the fall.	
Environmental status	This site, located on slopes just below the original settlement, is the most ecologically sound of all the Kembachen campsites. Site is gravelly and well-drained. Probably warmer than the meadow sites.	
Cost per night	Unknown. Probably Rs 150 for large tent, Rs 25 for small tent	
Other Uses	No evidence of other use.	
Photographs	Chris' 10-9

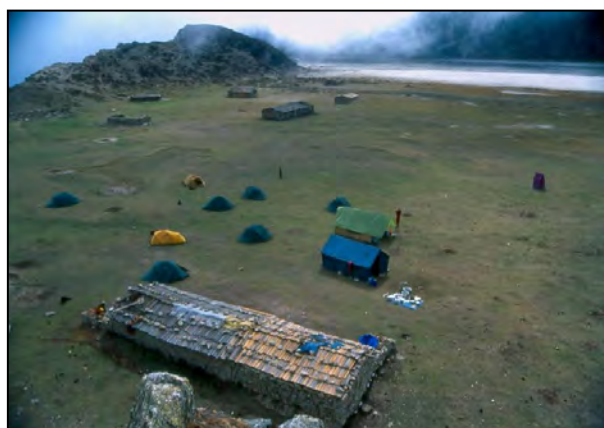
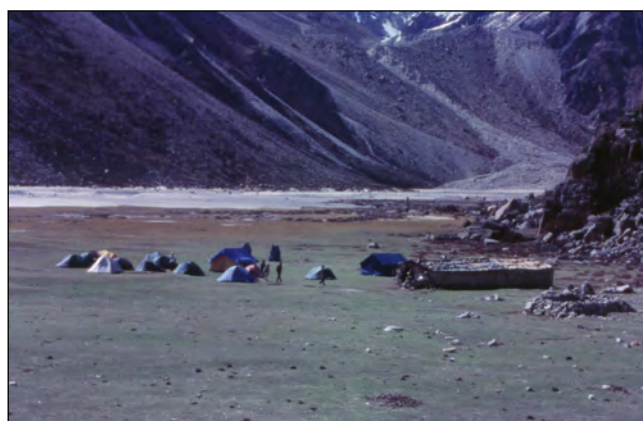
Number: 36	Place: Lhonak	Date: 5/16/01
Location:	27 deg 47.424' N, 88 deg. 02.205' E, 4770 m elevation	
Structures	6 traditional structures of stone and wood have been built to accommodate trekking parties at Lhonak.	
Facilities for Staff	Facilities consist of the 6 structures above. Each would accommodate 10-20 people.	
Campsite Condition	Lhonak consists of an expansive glacial outwash plain, undeveloped except for the 6 structures and some small, cultivated plots for growing potatoes. The area is sandy and well-suited to camping, although disturbance should be minimized as vegetation recovers very slowly at this high elevation. Best campsites at cliff base along north edge of the plain.	
Assets	Spectacular views, relatively warm and sunny. Well drained, grassy plain.	
Liabilities	Water is 10 minute walk across sandy outwash plain.	
Water Source	The nearest water is about 400 m across a sandy plain

Trash Disposal Facilities	Two open trash pits have been located in the center of the plain and mar the landscape. Trash blows across plain. They should be relocated to nearby rocky slopes.	
Human Waste Disposal	Individual parties provide toilet tents.	
Name of Caretaker		
Maintenance Schedule	Not maintained for camping, some lodges are staffed seasonally.	
Season of Use	Trekking business during early fall. Grazing activity in summer.	
Environmental status	Like Kembachen, Lhonak has received much recent construction. Facilities are probably adequate for the immediate future. People should be discouraged from developing this area further. Blue sheep frequent this area. Trekking parties need to be educated not to harass the blue sheep.	
Cost per night	Fee for camping collected if caretaker is present.	
Other Uses	Grazing

May 2002

May 2001

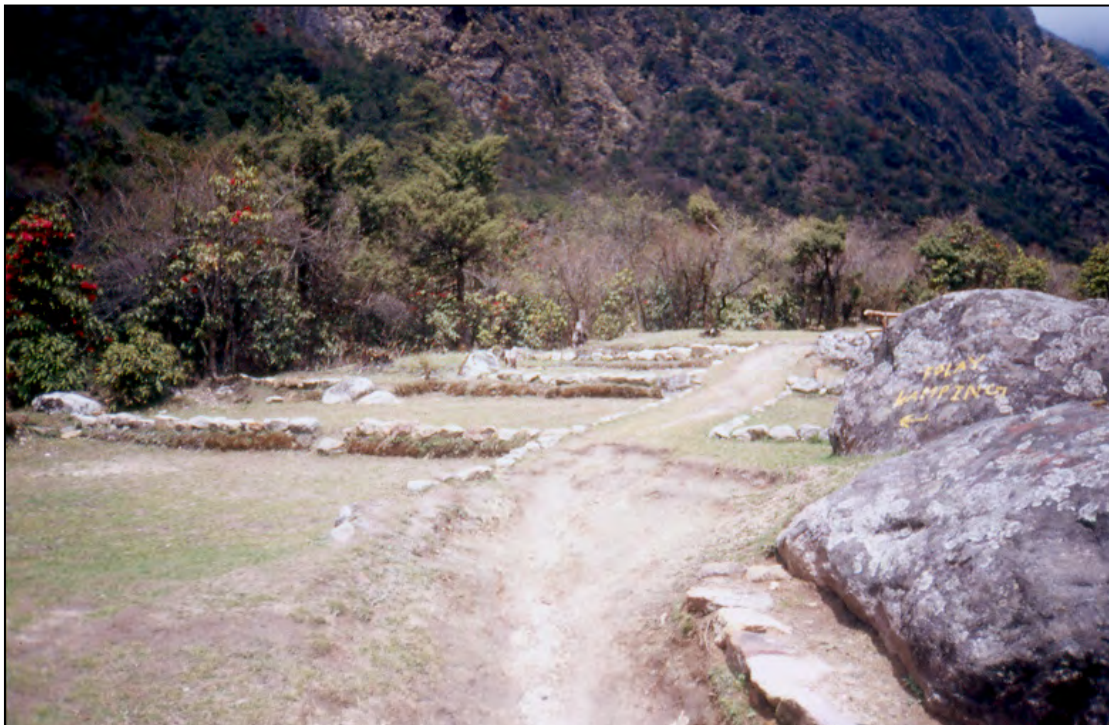
Number: 38	Place: Lower Phole Campsite	Date: 5/18/01
Location: Phole	27 deg 37.927' N, 87 deg. 54.915' E, 3165 m elevation	
Structures	One small building serves as a teahouse and shop, second kitchen building, both new, made of wood and stone.	
Facilities for Staff	As above	
Campsite Condition	Well maintained with tent terraces, no trash. Rocks laid around terraces mark campsites.	
Assets	Peaceful location away from town, sheltered by large boulders. Terraces are well-drained. Clean, water nearby. Ideal location from groups hiking from Kembachen to Amjilassa in two days.	
Liabilities	No toilet, groups must provide own toilet tents. Too soon to camp for groups coming up from Gyepla.	
Water Source	Stream on wooded slope adjacent to camp	
Trash Disposal Facilities	Open pit. This campsite is cleaner than most	
Human Waste Disposal	No toilet here	
Name of Caretaker	Mingma Sherpa	
Maintenance Schedule	Maintained year-round except summer.

Season of Use	Fall through spring, mostly during fall trekking season.	
Environmental status	Very good. No trash. Need to build toilets to avoid polluting nearby stream. Located away from river on sandy plain near glacial moraine.	
Cost per night	Rs 150/large tent; Rs 25/small tent	
Other Uses	None

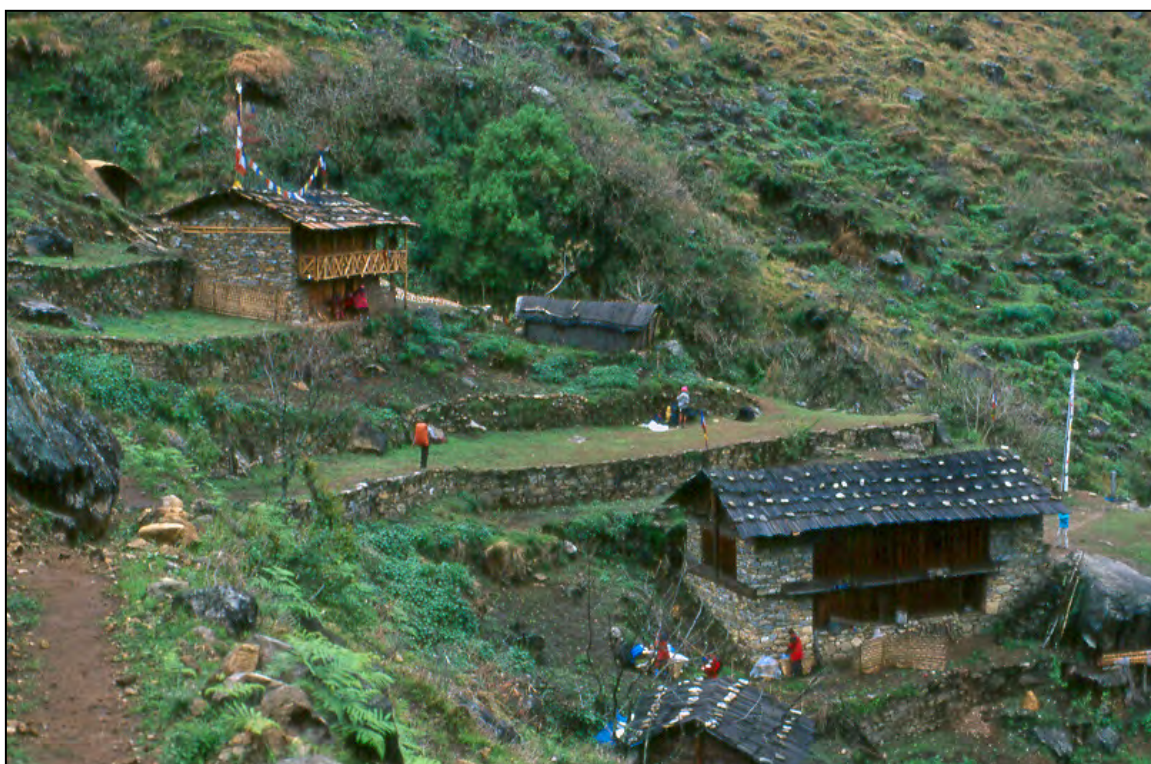
Number: 43	Place: Amjilassa / Lower site	Date: 5/18/01
Location:	27 deg 34.044' N, 87 deg 51.460' E, 2400 m elevation	
Structures	Lodge of stone, wood and bamboo. New residence located just above campsite, Kitchen hut of wood and bamboo.	
Facilities for Staff	Lodge offers staff accommodation	
Campsite Condition	Terraces are small and narrow. Dangerous 2m drop at edge of tent terraces. Mostly free of trash.	
Assets	Good view. Well-drained terraces adequate for medium-large trekking groups. Limited space for a second group.	
Liabilities	Lack of space for toilet tents. Human waste disposal is a problem at this site.	
Water Source	Faucet at campsite. Flow rate may be slow.	
Trash Disposal Facilities	Open trash pit	
Human Waste Disposal	No permanent toilet. Lack of space for toilet tents, except in vegetable plots. Much human waste around periphery of campsite. This aspect needs improvement.	
Name of Caretaker	Lhakpa Sherpa, lives on site

Maintenance Schedule	Maintained as needed	
Season of Use	Mainly during fall, available year-round.	
Environmental status	Good, except for human waste disposal problem. Terraces seem well built, camp located away from surface water in an ecologically tolerant location.	
Cost per night	Rs 25 for small tents, no need and no space for kitchen tent	
Other Uses	Tent terraces can also be cultivated.	
Photographs

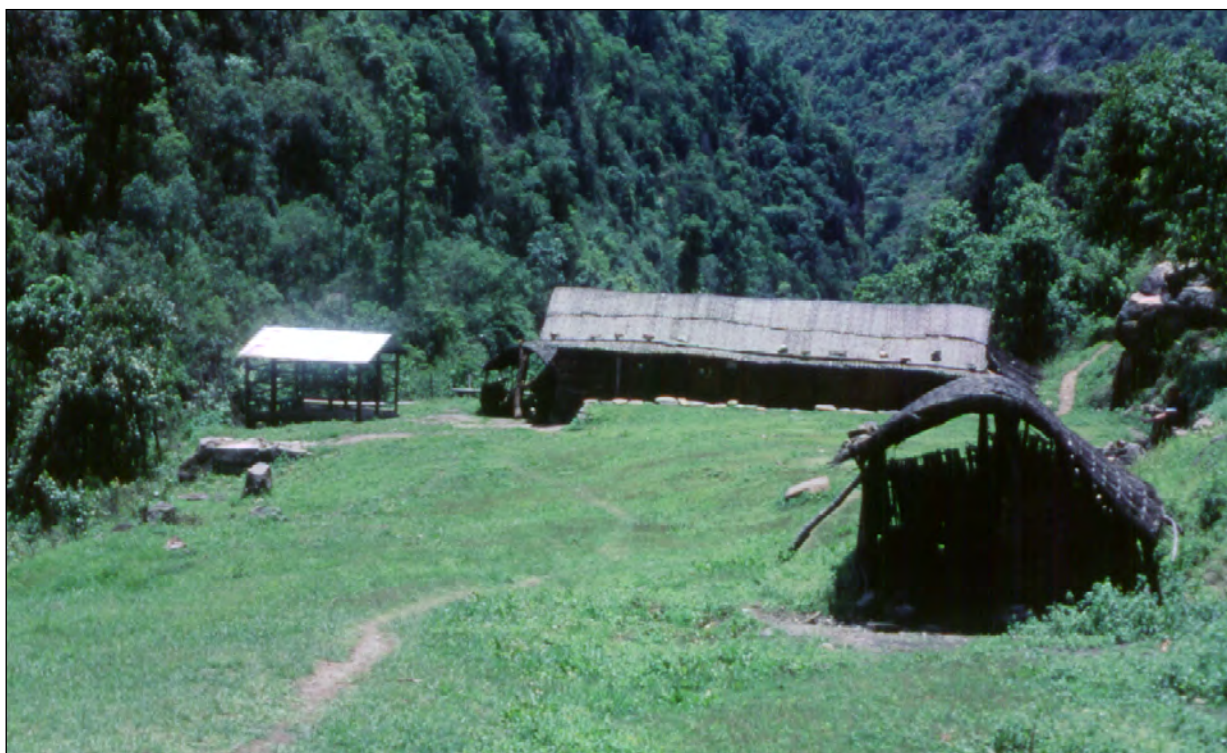
Number: 45	Place: Sakathum Upper Camp (NW bank of river, above bridge)	Date: 5/19/01
Location:	27 deg 32.171' N, 87 deg. 48.471' E, 1580 m elevation	
Structures	Lodge and tea house. Facility closed during our visit. Small covered area for lunch. Shelter for cooking with wooden walls and thatch roof.	
Facilities for Staff	Some lodging available on site. Houses in Sakathum, nearby.	
Campsite Condition	Site was clean with thick grass. Pleasant riverside location, well-situated between river and trail	
Assets	Pleasant riverside location, although the river is too swift to enter and difficult to access. Good views up Ghunsa Khola, convenient access to Sakathum Village.	
Liabilities	Camping area may be hot during the spring and early fall. Limited shade, except for covered dining area.	
Water Source	Uncertain. Probably Ghunsa Khola or nearby stream	
Trash Disposal Facilities	Needs improvement. Trash discarded along river bank behind lodge

Human Waste Disposal	No evidence of toilet facilities. Groups that camp here should be advised to put toilet tents away from the river.	
Name of Caretaker	Not known	
Maintenance Schedule	Not known	
Season of Use	Mainly fall and spring. Site was closed during our visit in mid-May	
Environmental status	Good except that much trash has been discarded along the river bank behind the lodge. Otherwise clean and well situated group campsite.	
Cost per night	Not known	
Other Uses	Limited grazing	
Photographs	Yes

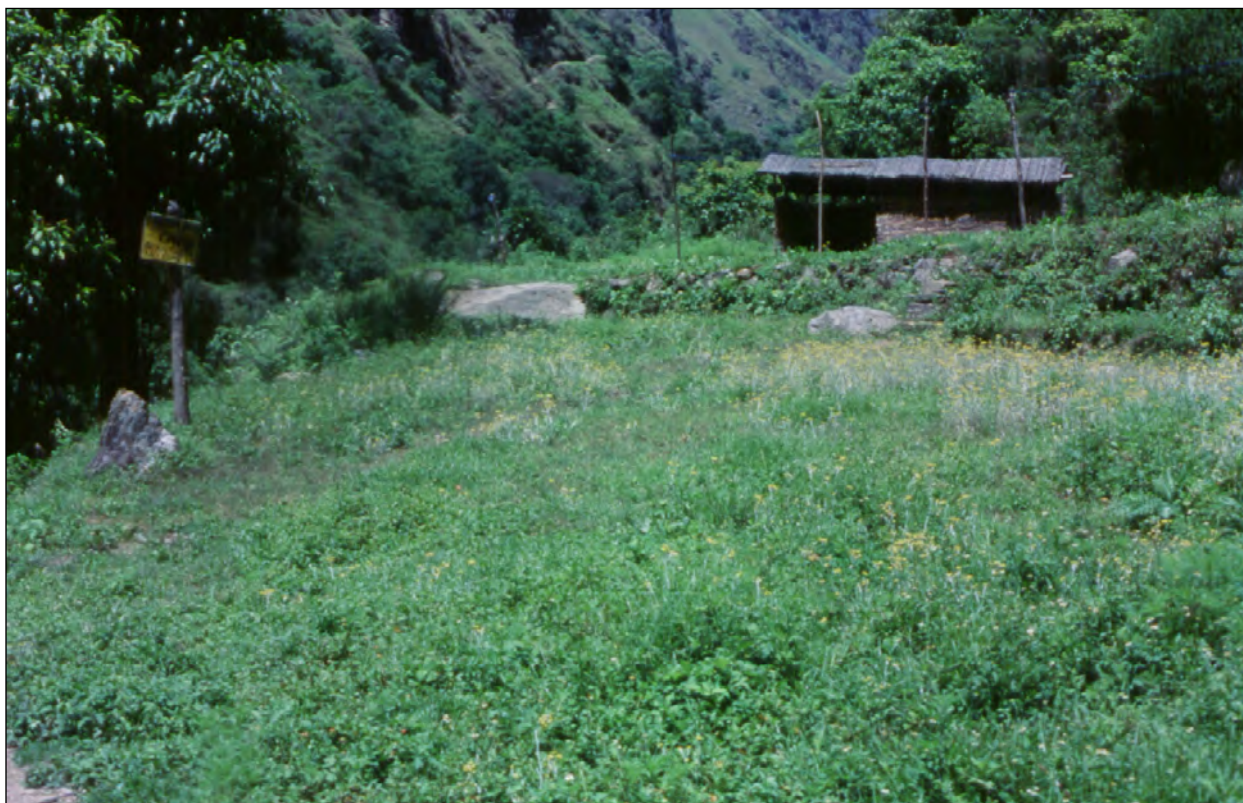
46	Yangjom Hotel and Trekking Camp	5/19/01
Location:	27 deg 32.057' N, 87 deg. 48.362' E, 1550 m elevation	
Structures	Small cooking shelter on site. Yangjom Hotel offers additional cooking facilities and accommodations for porters. Sakathum village is 15 minutes away.	
Facilities for Staff	Yangjom Hotel and Sakathum Village	
Campsite Condition	Small but adequate grassy terrace	
Assets	Close to river, lodge nearby. Good aiselu berries in spring season.	
Liabilities		
Water Source	1 minute walk to Ghunsa Khola	
Trash Disposal Facilities	Trash is taken by caretaker to local KCAP site where it is burned or buried.	
Human Waste Disposal	none	
Name of Caretaker	Dorje Sherpa resides on site	
Maintenance Schedule	as needed	
Season of Use	Facility is open year-round.	
Environmental status	Site is reasonable. Fuelwood use is probably justified at the low elevation site.	
Cost per night		
Other Uses	Grazing site

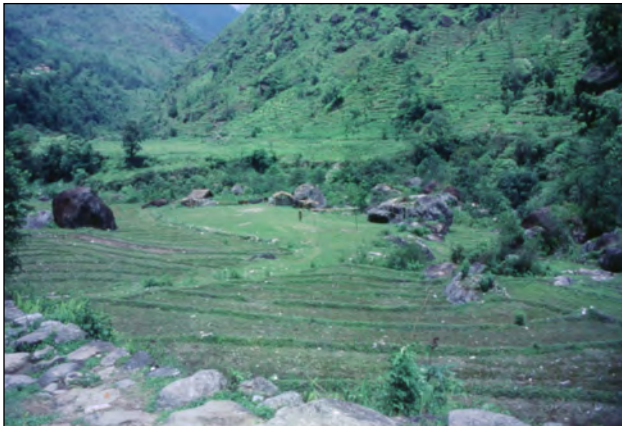
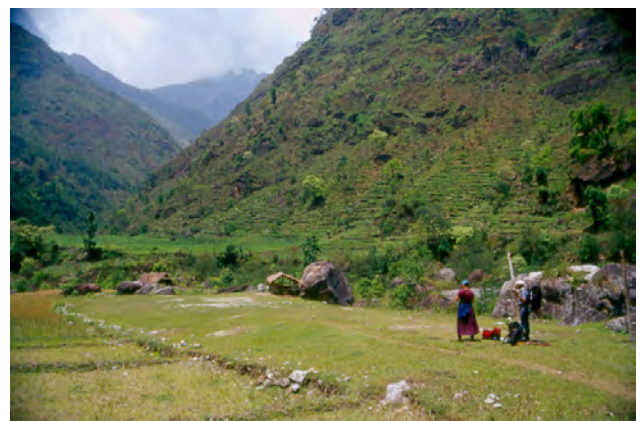
Number: 47	Place: Chiruwa	Date: 4/27/2002
Location:	5 minutes NE of Chiruwa between path and river	
Lat. / Long.	27 deg 29.405' N, 87 deg 44.676' E	Elevation: 1240 m
Structures	1 kitchen, 1 small shelter for porters	
Facilities for Staff	Homes in nearby village	
Campsite Condition	Little recent use, little recent maintenance, otherwise good condition with large, flat camping area	
Assets	Optimal distance from village, access to river	
Liabilities	River too swift for swimming	
Water Source	Stream and Tamur River nearby	
Trash Disposal Facilities	Pit, garbage collected by caretaker	
Human Waste Disposal	Groups need to dig charpie holes, supply tents.	
Name of Caretaker	See Chiruwa Tea House #1	Age of site: Reportedly used as camp since 1972
Maintenance Schedule	As needed	
Season of Use	Trekking season as needed	
Environmental status	Seems to be in reasonable condition, some trash	
Cost per night	50 NRs/member tent, 100 NRs kitchen tent

Other Uses	Grazing pasture, sports field

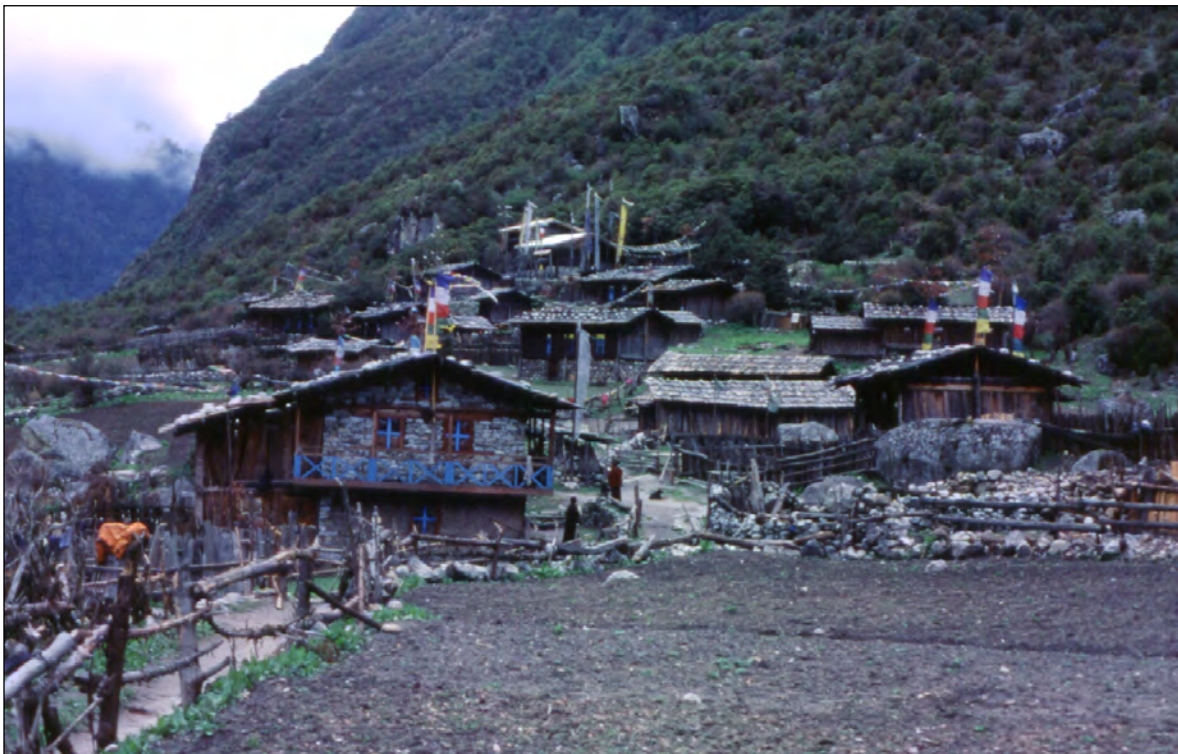
View down valley of [Tea Shop] (nearest building, with blue trim) and Phole Village. Note monastery complex in top center with yellow roof. 13: 1

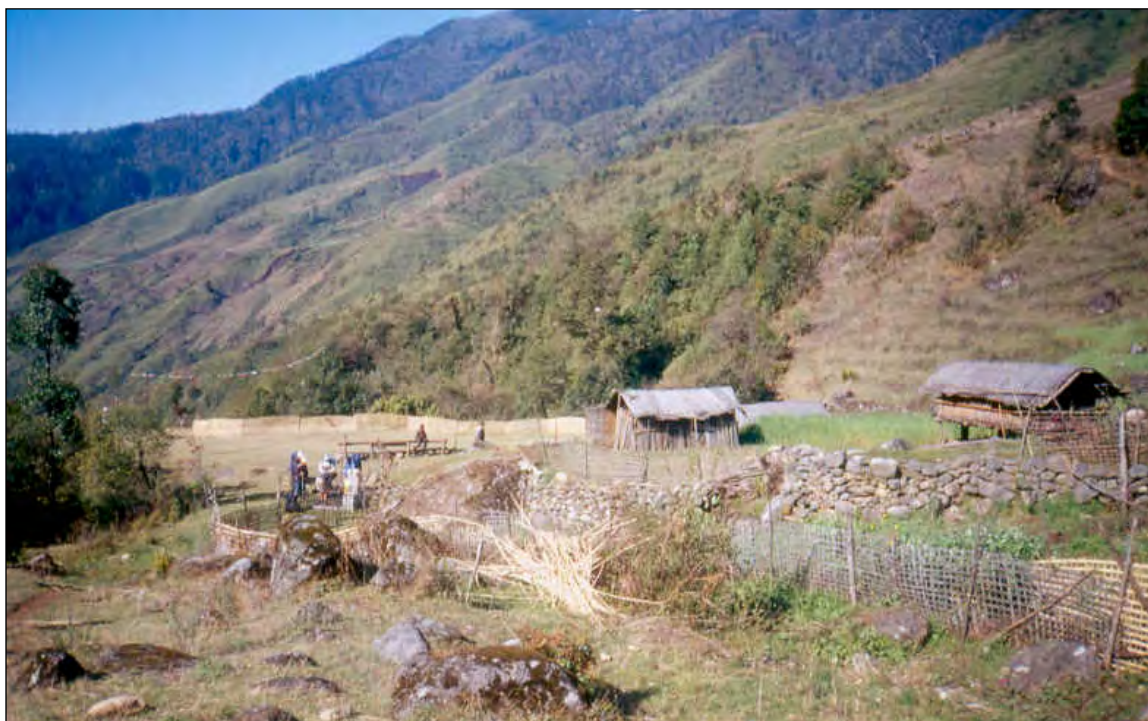
Photo taken down valley toward campsite from the front of the lodge

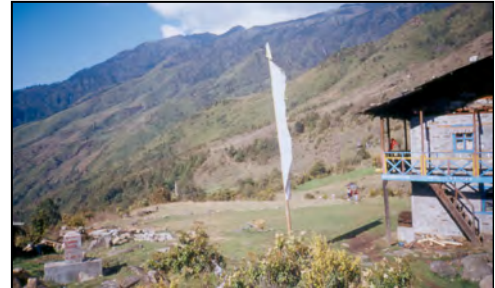
Structures	Two story lodge with kitchen hut
Facilities and Services	Lodging and large kitchen available for camping groups. Staff and trekker accommodations.
Cost for Goods

View of Lodge and Campsite

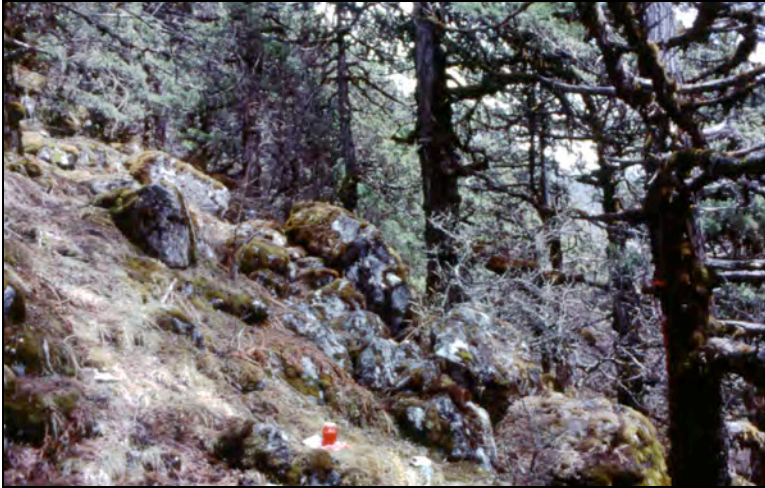
**12.** Cairn marker on tree to right of red paint jar.

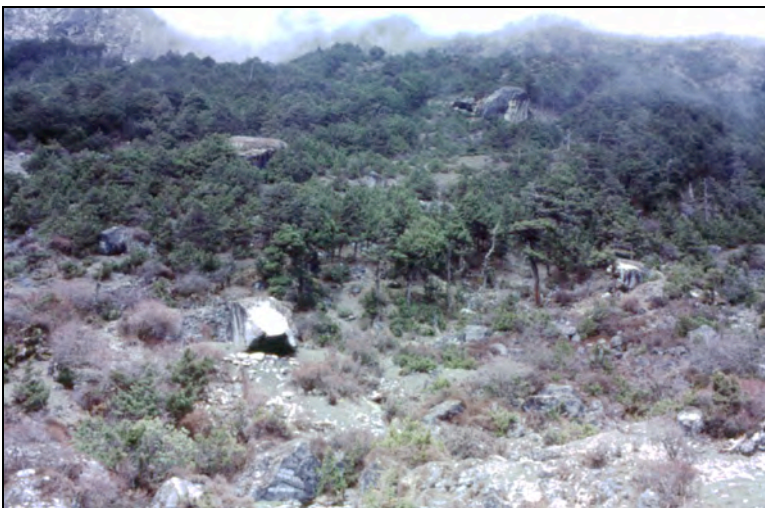
Plots S-5 and S-6 below, plots T-3 and T-4 higher up on same slope.

Photo station at  $27^{\circ} 34.185' N$ ,  $87^{\circ} 58.624' E$ , just behind Tseram Campsite "C." Shooting  $310^{\circ}$  NW with 28 mm lens.

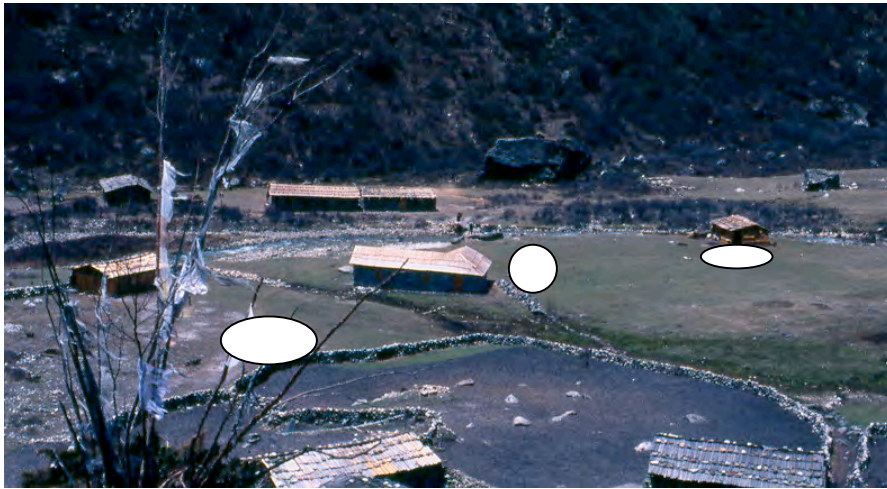
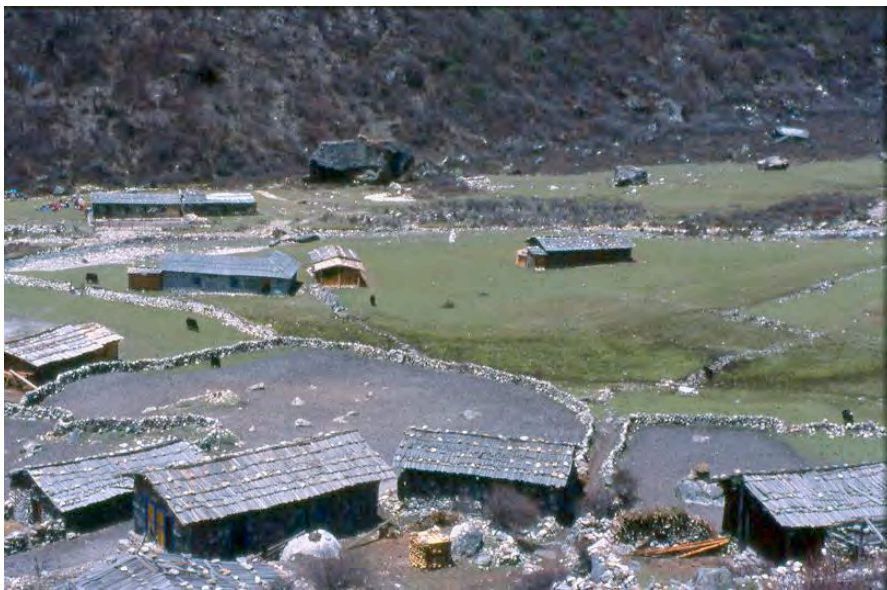
Ongoing Development in Kembachen since inception of KCA in 1998.

Structures in the middle distance all have been built since 1994. Locations indicated by yellow marks in the top photo were developed between 1998 and 2002. These structures are built of rock and planks of *Abies* fir by the residents on Ghunsa Village. The meadow and streamside locations are advantageous for attracting tourists and their staff, but the hillside locations are more ecologically suitable for construction.

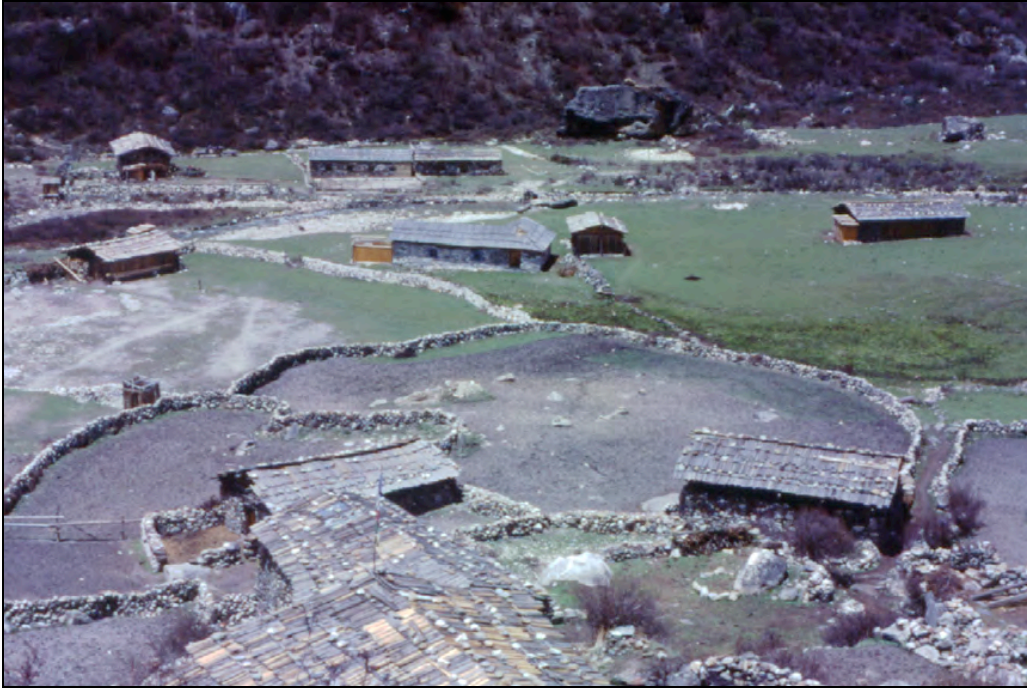
Looking southwest across Kembachen valley. Structures in the foreground are old family residences, used seasonally by the inhabitants of Ghunsa. Structures in the distance have been constructed during the past five years as tourist lodges.

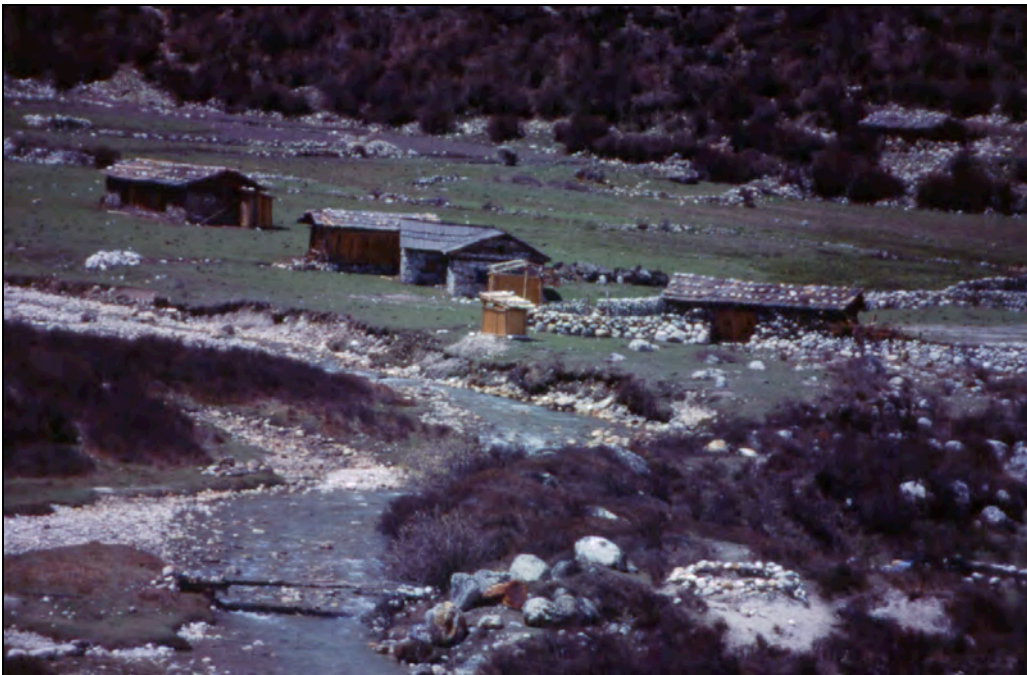
Looking north across Kembachen valley. These structures have all been built by Ghunsa residents since the KCA Project was first publicized in 1997.

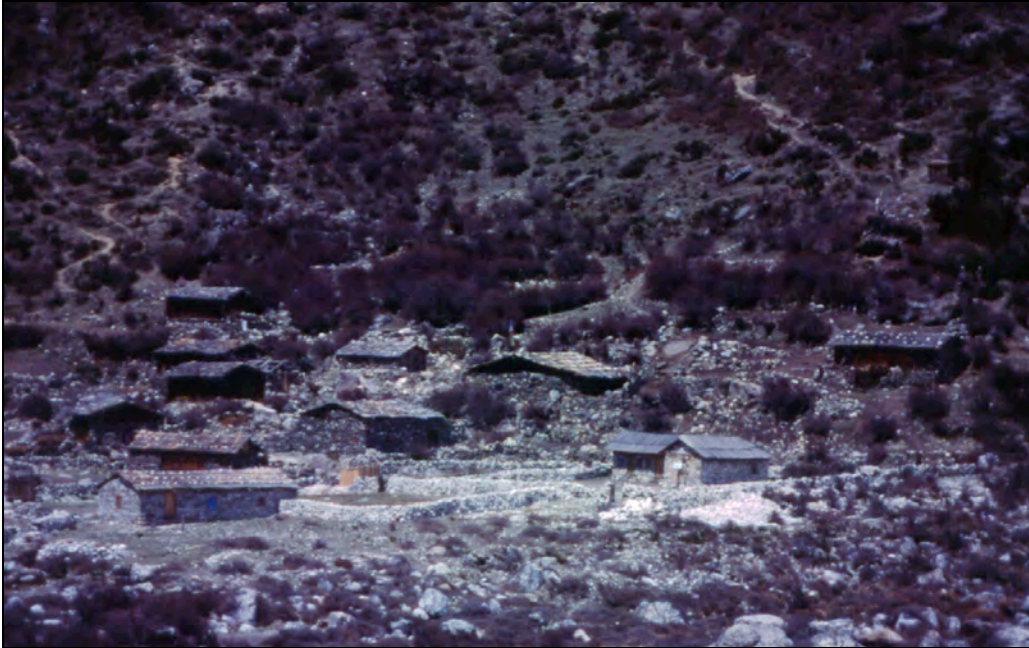
The Old Part of Kembachen. Some of these structures appear in photographs taken more than 100 years ago. See Douglas Freshfield. 1903. *Round Kangchenjunga*. Edward Arnold, London. Plate following p. 178. Reprinted in 2000 by Pilgrims Publishing, Kathmandu. The hillside location is warmer and more ecologically resilient than the nearby valley bottom where lodges have been built recently to attract tourists.

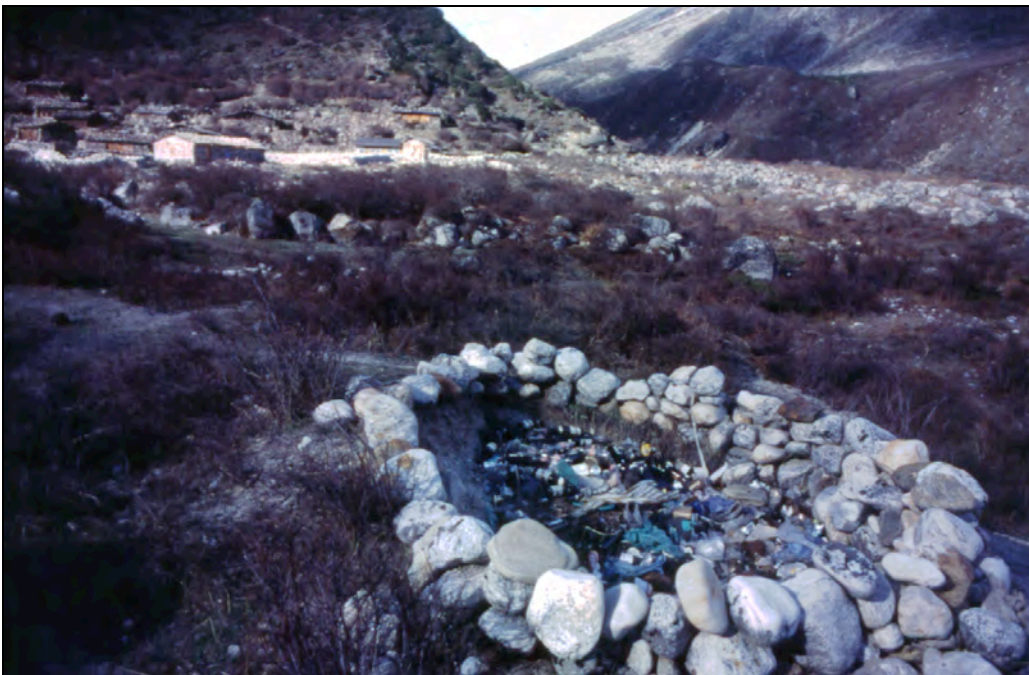
Kembachen community trash pit, located at the southwestern corner of the valley.

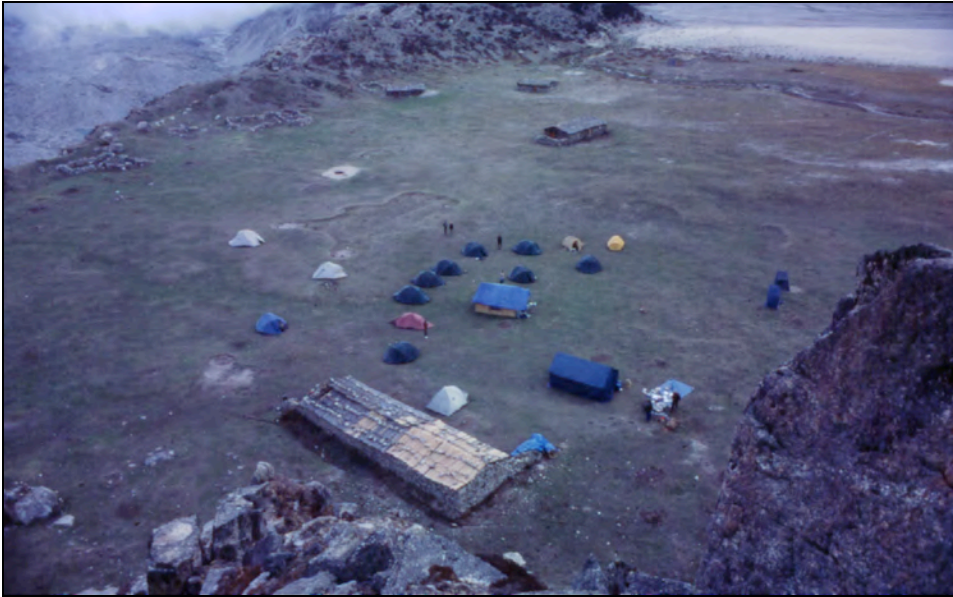
The camping area at Lhonak is located on an expansive glacial outwash plain, 4770 m elevation. Note the open trash pit that resembles a bomb crater in the upper right quadrant of the photo. All of the structures visible in this photograph have been built in the past 4 years in anticipation of increased tourism as a result of KCAP initiatives.

Photograph station at  $27^{\circ} 47.439' N$  latitude,  $88^{\circ} 02.225' E$  longitude.

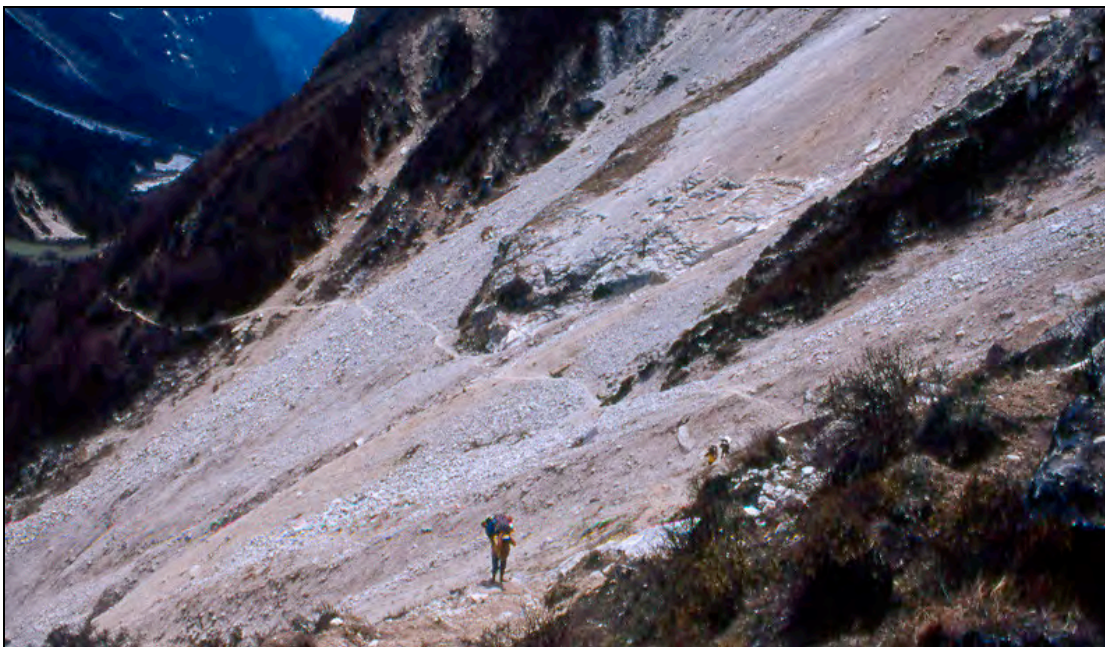
The path from Ghunsa traverses a large landslide before reaching Kembachen
